Windshield Wiper Over Travel

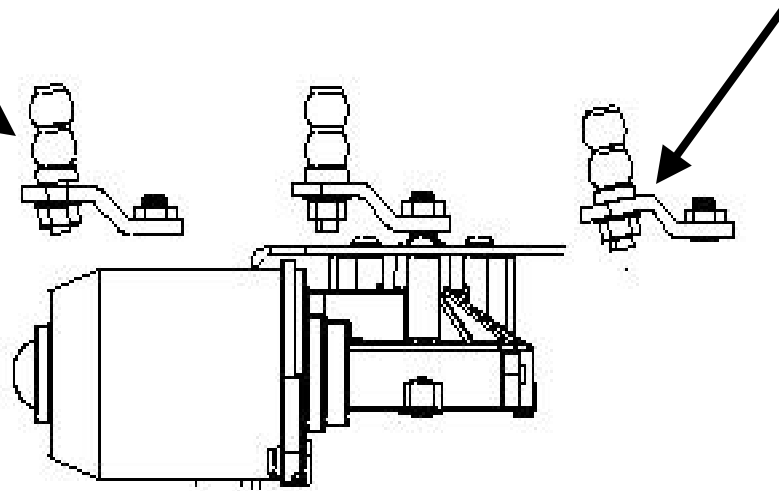
(Fig. #3)

- Reasons over travel may occur.
- Bent drive arm on motor (fig. #3).
- Loose drive arm stud (fig. #3).
- Wiper motor mount bracket mounted to right or left of correct location.
- Incorrect length of drive arm on motor (check I.D. # on link). (fig. 2)
- Incorrect connecting link length.
- Incorrect wiper pivot arm length.

Loose drive arm stud.

Bent drive arm.

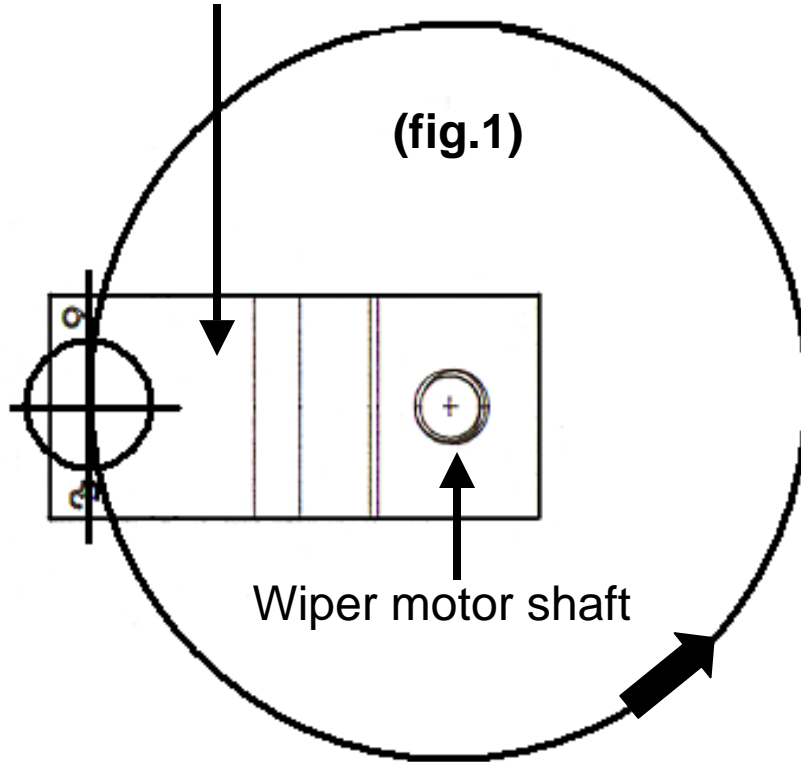
Wiper Motor drive Arm

Drive arm bent or Stud loose in drive arm will increase radius between motor shaft and stud with result of increased circumference of travel which will result in over travel of both wipers. See (fig. 1)

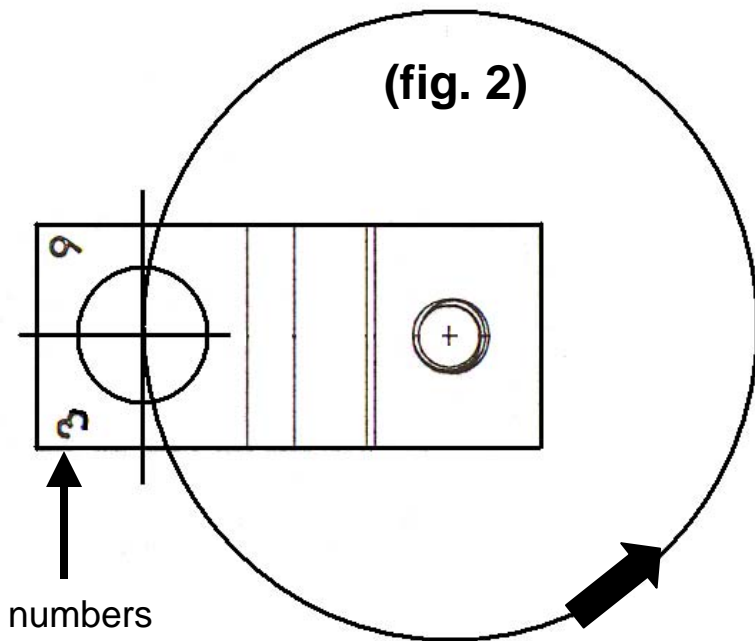
Drive arm that is straight and stud mounting nut with proper torque will have correct circumference of travel. (fig. 2)

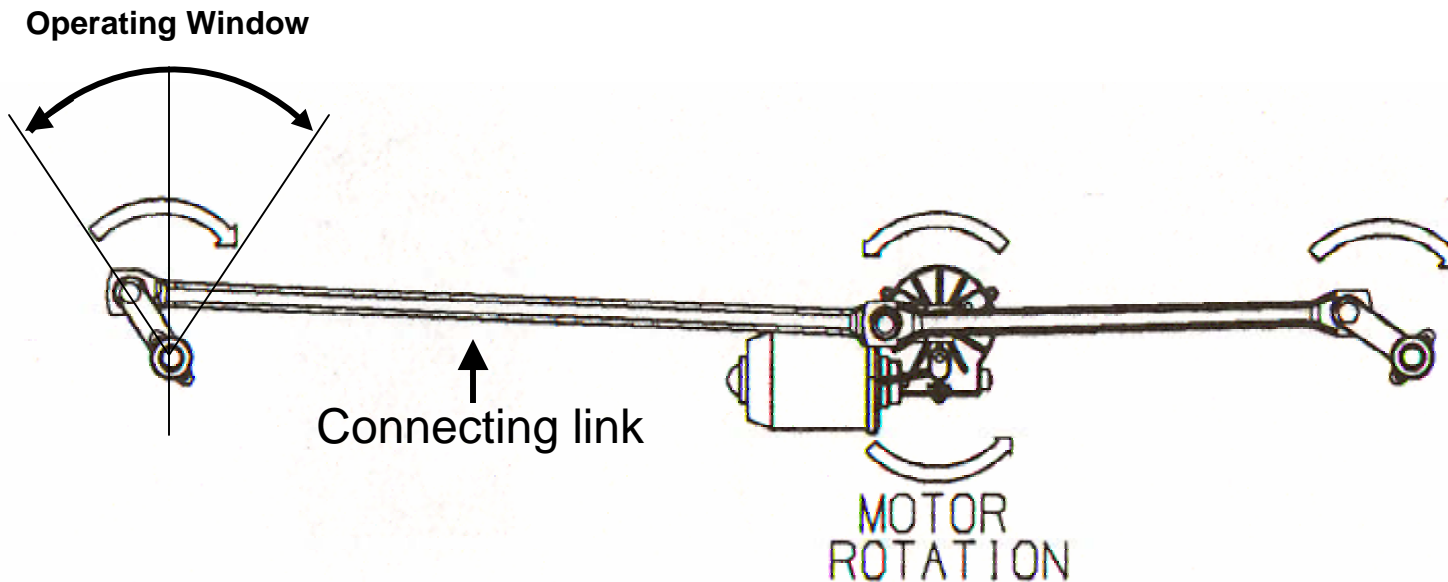
Wiper configuration used with one piece windshield.

If wiper motor bracket is mounted to far right or left of design intent position the pivot arm will be out of the operating window which may cause wiper to over center.

Correction: Shorten or lengthen wiper connecting link approximately 10 mm to assure pivot assembly is within the operating window.
