On our 2013 Winnebago Journey 42E (SN: 10P96P273402) and noticed that compartment area that has the motor assembly for the Passenger side Full Wall slide (front passenger side, right behind front wheel) that there is a lot of road grime and mud from when we had to travel in some snow late last year. I did notice some surface rusting and will try and clean that up, but when looking at the issue, it appears that there is a path for water and road debris from the tire to be able to get into the area that this motor is stored.

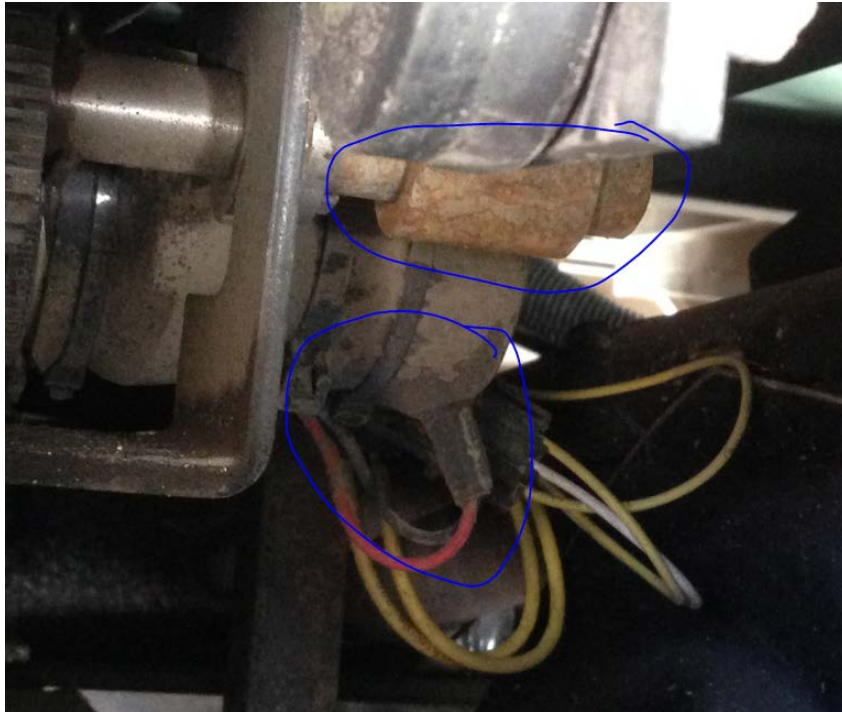
Parts starting to rust

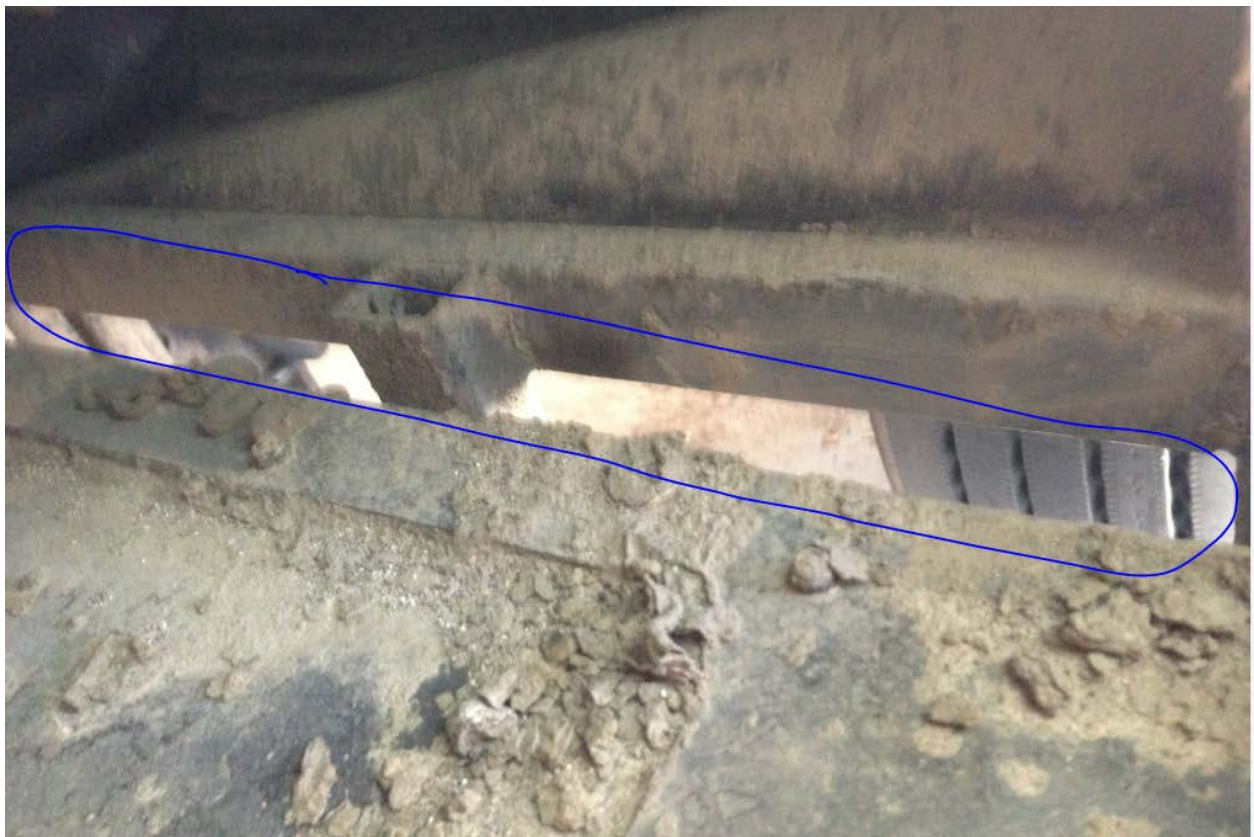
The third picture below shows a view from the slide-out motor compartment and you can see the ground and the front tire from that point.

This is from the slide motor compartment looking down to the road

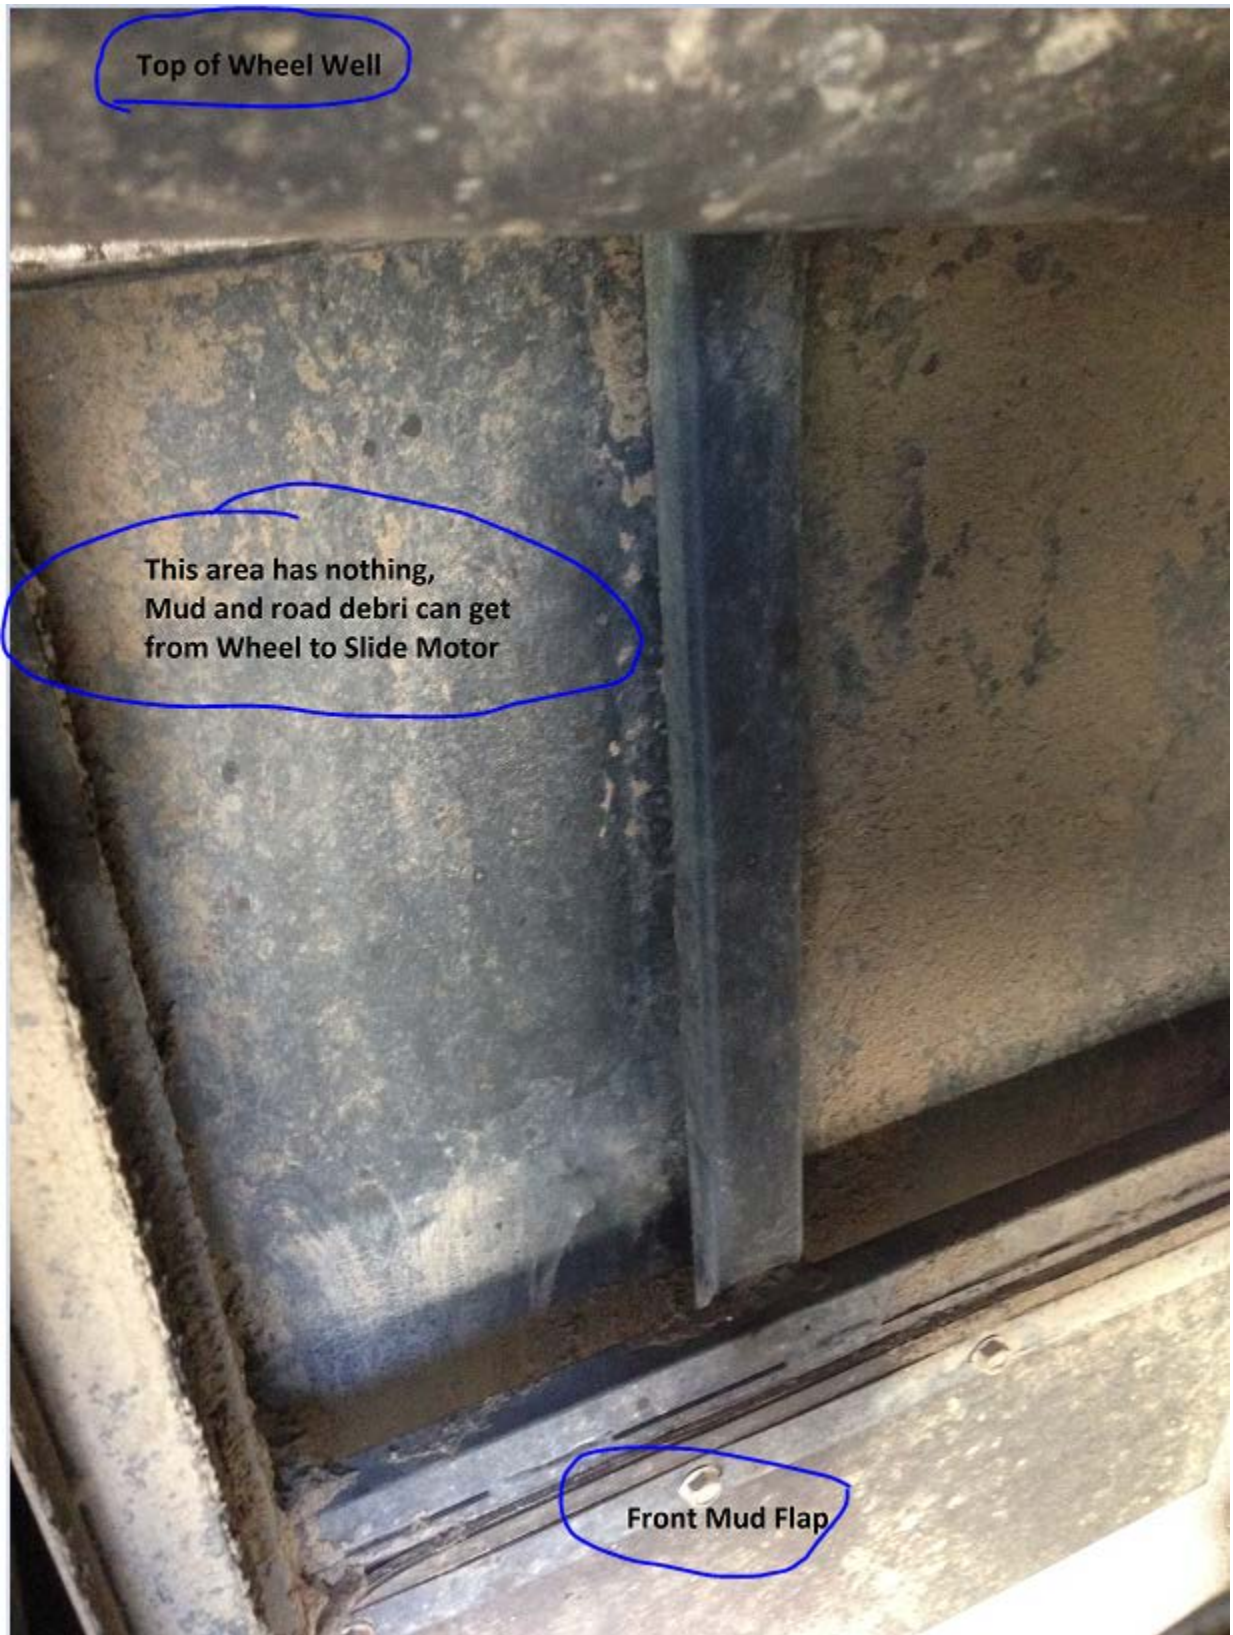
The fourth picture shows the mud flap on the bottom, then a blank space and then over the top is another piece of rubber that protects for road grime the rest of the way.

Top of Wheel Well

This area has nothing,
Mud and road debri can get
from Wheel to Slide Motor

Front Mud Flap

Can we get these bars and the rubber material that was done on driver side ?

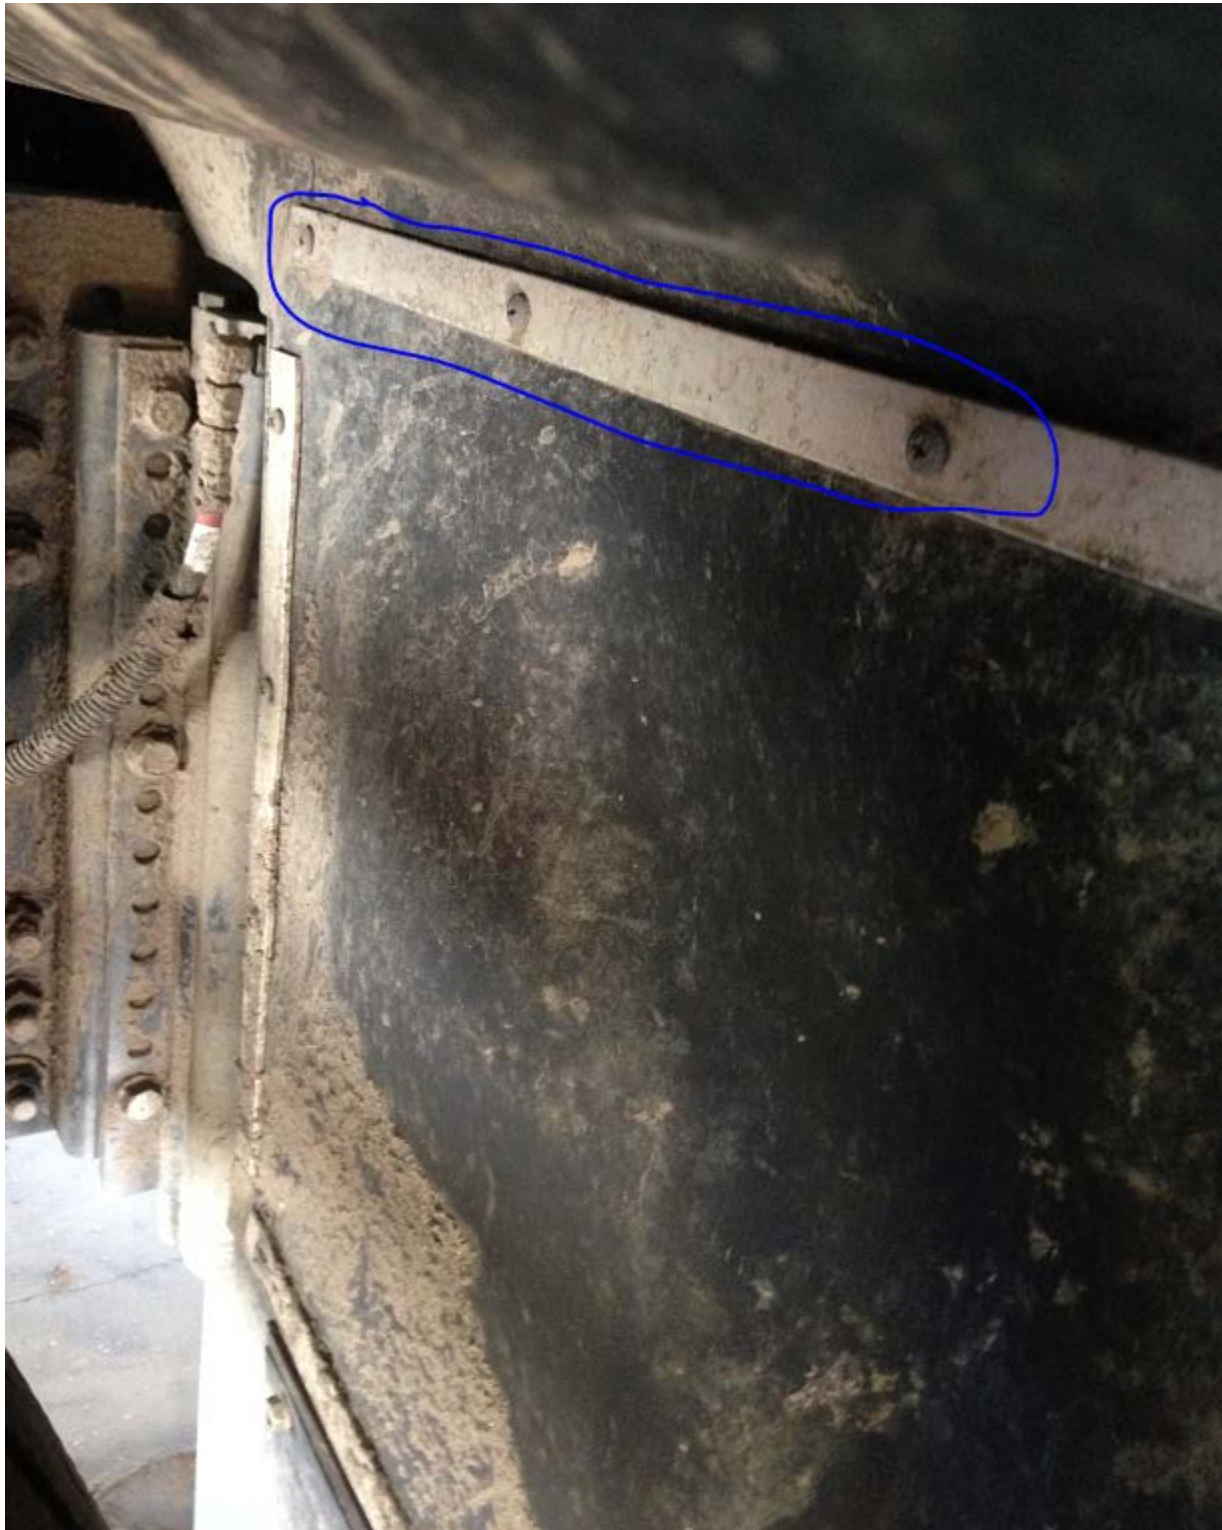
Checking the Driver side, this area DOES have a piece of rubber that protects the compartments behind it. (Fifth Picture)

Is it possible to get some of the rubber material and flat metal bar that holds it in place to fix this issue, as I worry how long the mechanism had can hold up to water and dirt getting into it.
