The information in this document were prepared by Jim Godward and Jim Epting.

As originally diagnosed by Jim Godward, the Vehicle Data Unit (VDU) installed in the 1999-2001 Freightliner chassis has significant manufacturing quality control issues. The issues have lead to erratic performance and some frustrating instrument cluster problems, though non of the problems are known to have caused a shut-down or need for road service. This note addresses one of the instrument cluster issues, false low air pressure warnings on both the warning light and pressure gauge. (In fact, the Freightliner representative at the 2006 Quartzite Newmar Rally indicated that the vehicle would run and drive without an operating VDU, but with no instrument panel gauge operation. This is untested by the writer.)

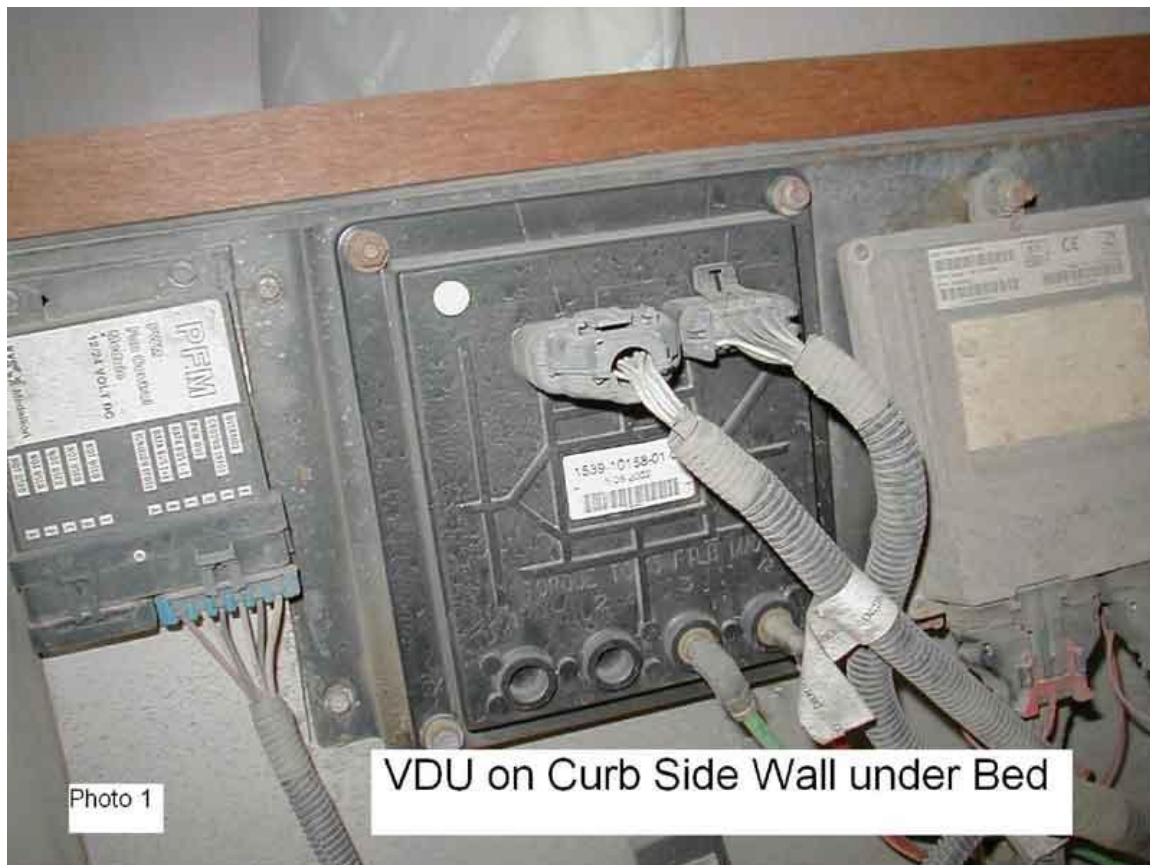
The VDU is a small black box which gathers and conditions various vehicle data destined to be displayed on the drivers instrument panel. This data is multiplexed onto a single digital bus, and passed to the instrument cluster, where it is de-multiplexed and displayed by the various individual instruments. In the 1999-2001 coaches, the box is attached to the curbside vertical engine bay wall, accessible by lifting the under-bed engine hatch. The box is approximately six by seven inches, less mounting flange, and one inch thick. It is attached by four small bolts in the corners, with rubber shock mounts surrounding each mounting bolt. The VDU has two multi-wire quick disconnect plugs and two small air lines of ¼ inch diameter attached. The airlines are color coded red and green and are apparently routed to the front and rear air brake reservoirs. The VDU is easily identified by looking for the color coded air hoses. Photo 1 below show the VDU mounted in under the bed in the engine compartment. The mounting bolts, quick release plugs, and the air lines are clearly visible.
