Paul Potter
2013 Winnebago Journey 42E
SN: 10P96P273402

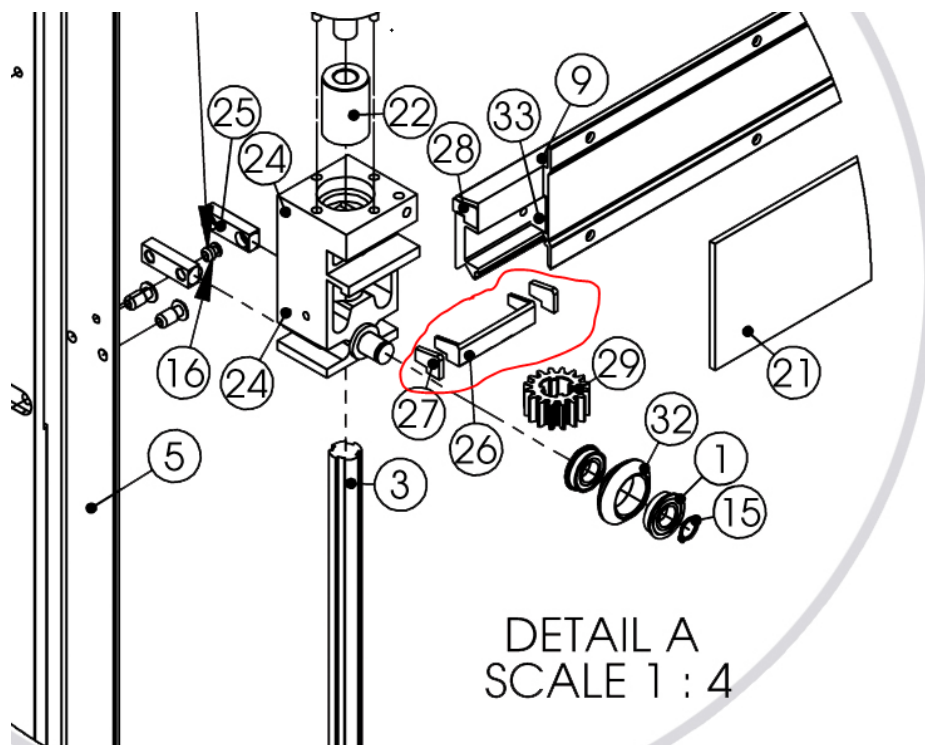
On the rear mechanism of the front Driver side slide, after it was removed, they discovered that the bearing block (item 24) had damage on the edge that goes into the track along with the plastic room slide shoe (item 26 & 27). It appears that the plastic room slide shoe broke, which then allowed the bearing block (24) to twist into the hook rack (28) and not let the slide move in.

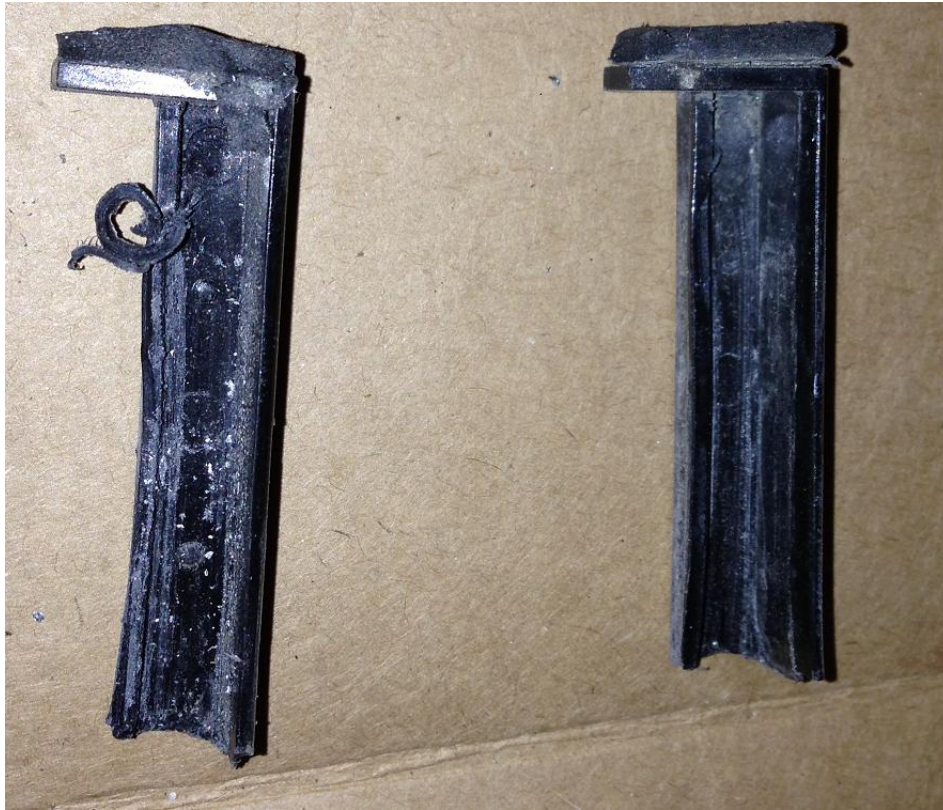
This is a picture of the broken plastic room slide shoes that failed on both front and rear slides after only 10-15 opening/closing.

Both of these slide mechanism for the driver side front slide only had 10-15 opening and closings on them before they failed, and this was the second set of slides (the improved ones) and they lasted about the same amount of openings.

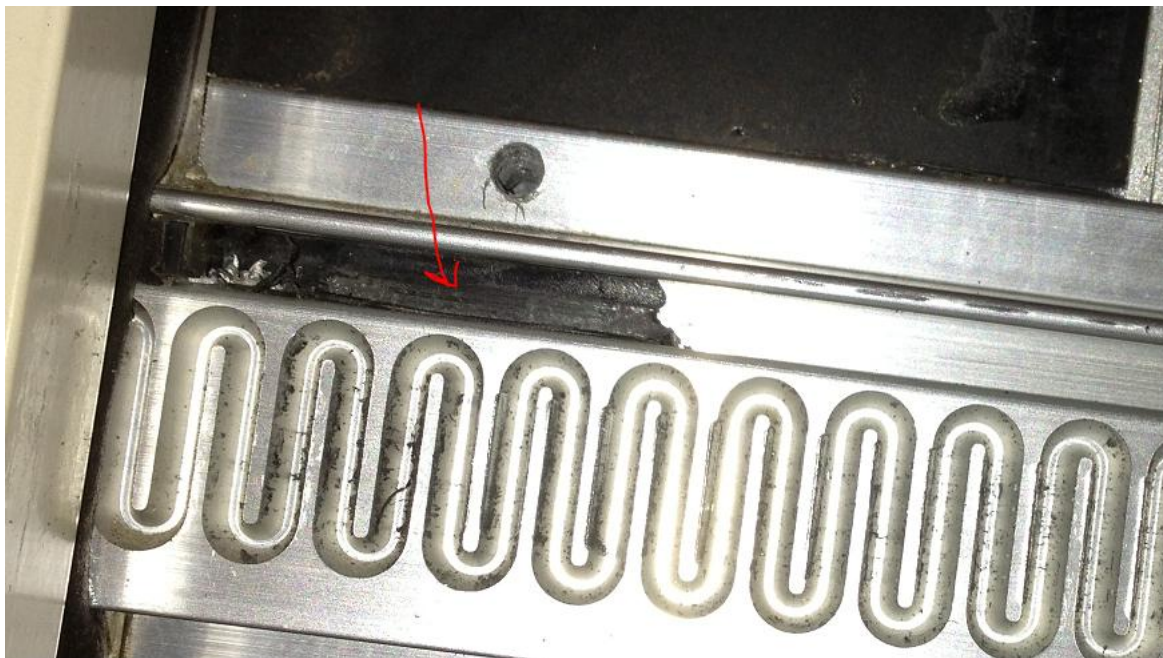
This is a picture of the plastic shoe that was broken inside the front half of front driver slide, you can see how one side was broken off and allowed the metal bearing block to float in the tracks.

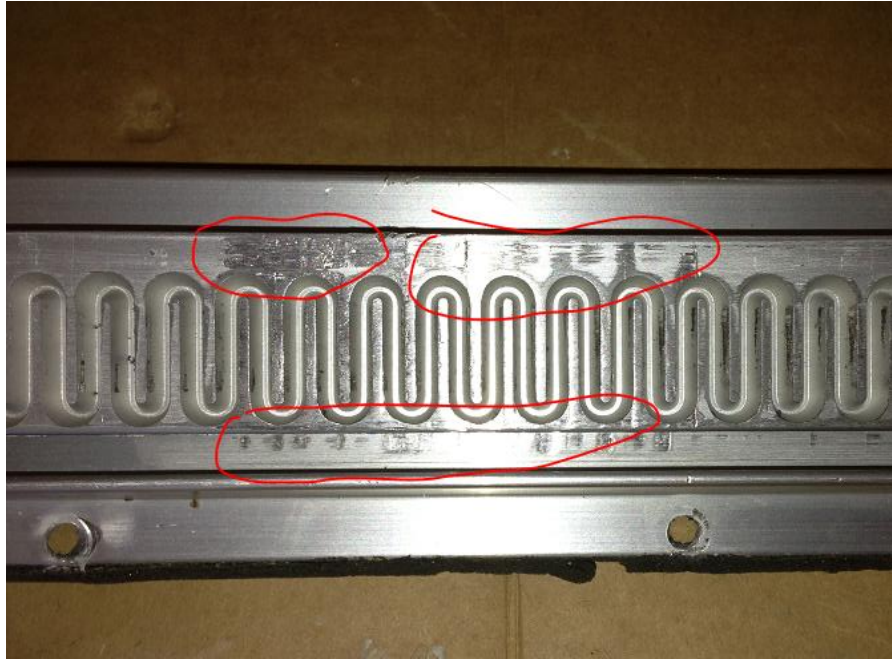
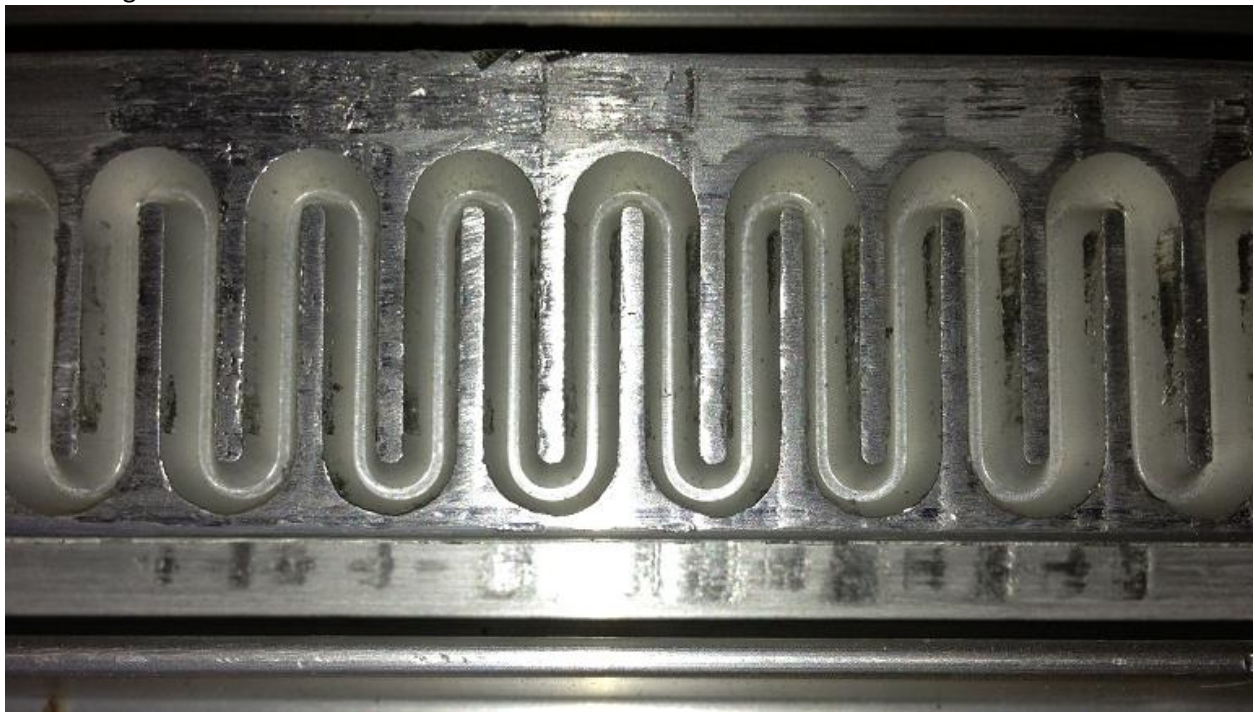
Here is the track where the bearing block was binding on the track and making the popping noise and

not moving well.

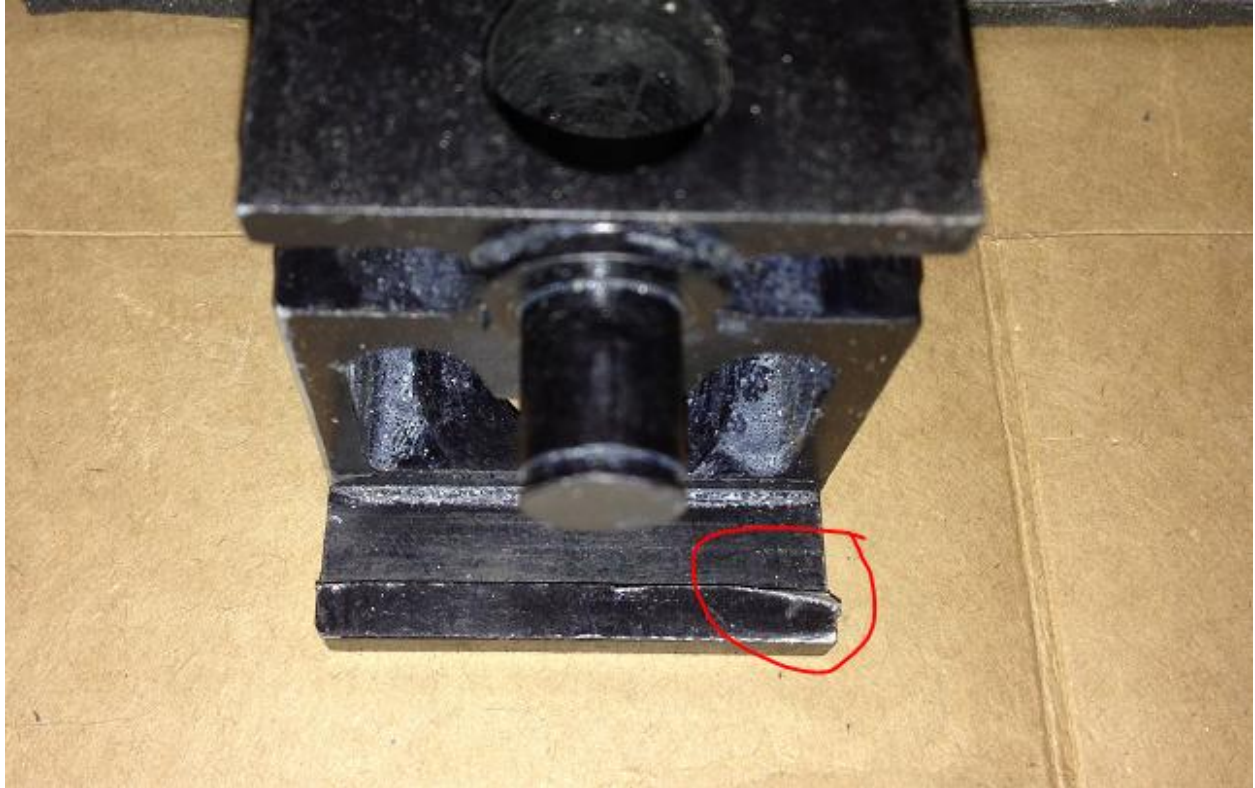
Here is a picture of the bearing block, where the shoe had broken off and it was rubbing metal on metal with the track.
