Atwood (Excel) Window Condensation Repair

This is the window that forced me to begin this project. If you are taking the time to read this, I suspect that you either have or have had a similar condensation or moisture intrusion problem with an Atwood Mobile Products thermopane window.

I have a 2002 Itasca Suncruiser 37G which was manufactured by Winnebago Industries. This is my second motorhome (my first Winnebago product), and overall I am extremely pleased with the quality and workmanship.

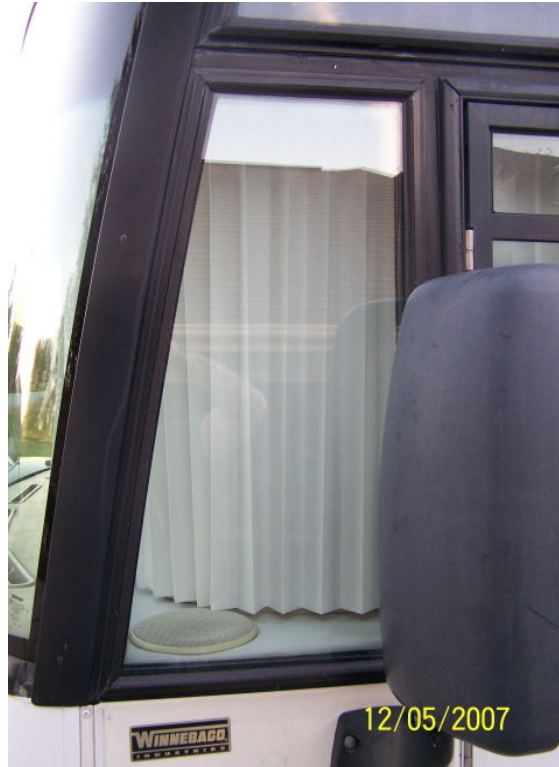
After Glass Replacement – Nice and clear !

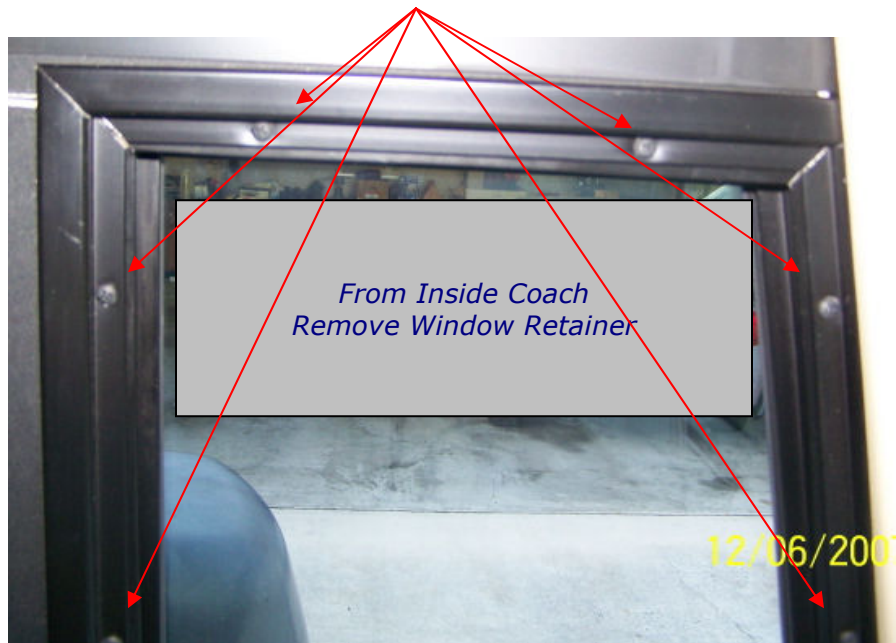
Phillips Head Screws

Interior side of Window Frame

To remove the window assembly, from outside of the coach, remove the aluminum "A Pillar" cover (3 screws). In the lower left corner of the window frame, remove the two (2) screws, which help secure the window to the frame of the coach. Move inside the coach, and unscrew the interior window retainer.

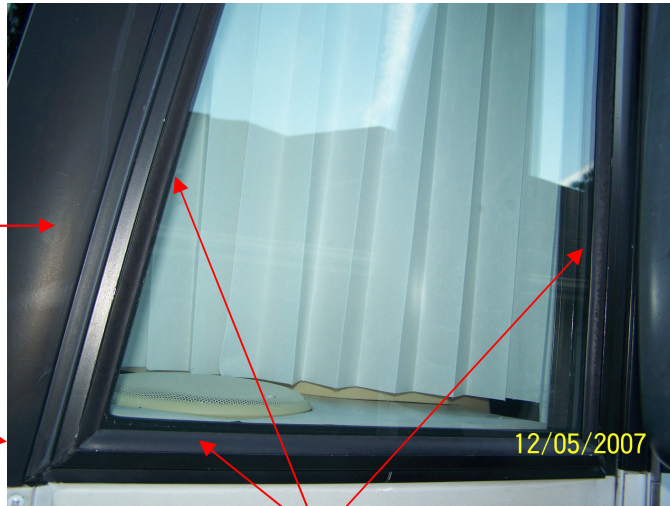
Remove Aluminum
"A" pillar cover
(3 Phillips Head Screws)

Remove screws
under the "A" pillar
cover
(2 Phillips Head Screws)

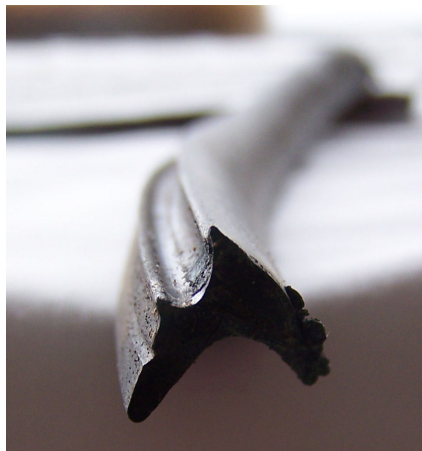
Outer Rubber Seal

Remove Rubber Outer Seals

Set the rubber outer seals aside to clean up and re-use.

Re-install the rubber outer seals. They should fit tightly, and are easier to re-insert if you twist the rubber seal slightly as you push it back into place. Use a small amount of black silicone sealant in the four corners to fill the gaps.

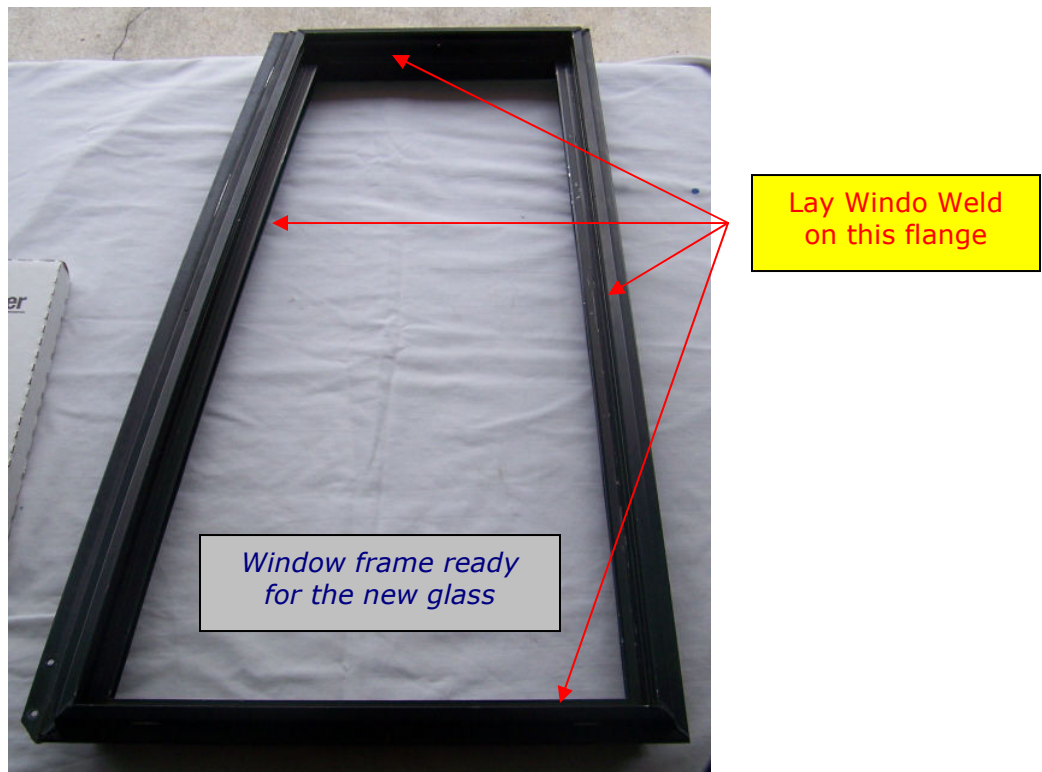
Window Frame without glass

Once the glass is out of the frame, clean the old butyl tape of the inside of the aluminum frame. You will likely find two small plastic rectangular blocks near the bottom inside of the frame. These are called setting blocks and will be reused. Clean them up and set them aside.

Lay the frame face up, and prepare to reinstall the new seal and the glass.

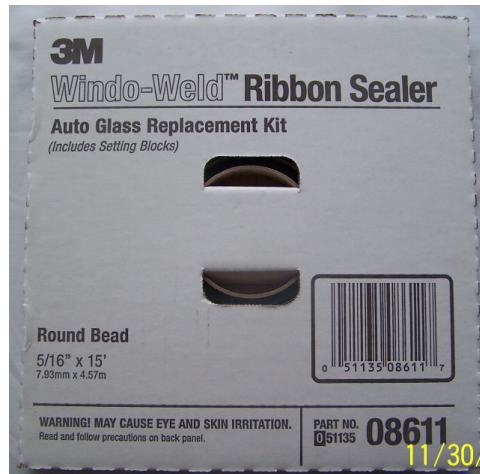
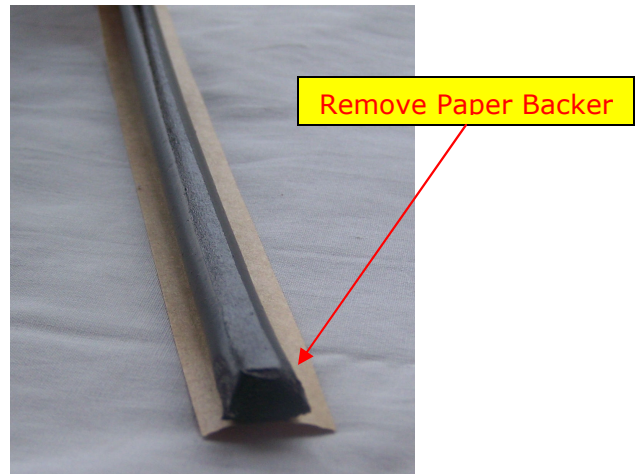
3M Windo Weld 5/16" x 15'

To reinstall the glass, I used 3M Windo Weld, which is bead butyl tape. I purchased it off the shelf at my local auto body supply house. I found it through the 3M website. The roll was \$9.85 plus tax.

CAREFULLY, lay the Windo Weld along the inside flange of the window frame, replacing the original butyl seal. I found that gently rolling the tape in your fingers would best allow the transitions through the corners. The auto glass folks also told me to **start the bead near the top of the frame**, so the seam will be less subject to water intrusion. The Windo Weld should seam together nicely with a slight overlap.

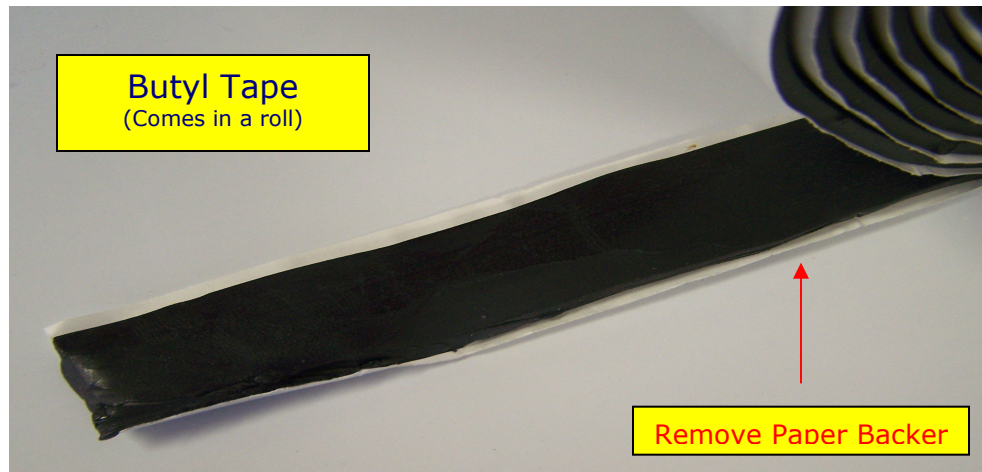
Lay the window face down. Utilizing the black butyl tape, carefully lay the butyl tape on the inside flange of the aluminum window frame. The butyl tape is fairly sticky, but generally can be repositioned if you don't apply any pressure when applying. After you have the butyl tape laid out, gently lift and re-position any section that needs to be adjusted. LIGHTLY press the butyl against the aluminum frame. The window should now be ready for re-installation into the coach.

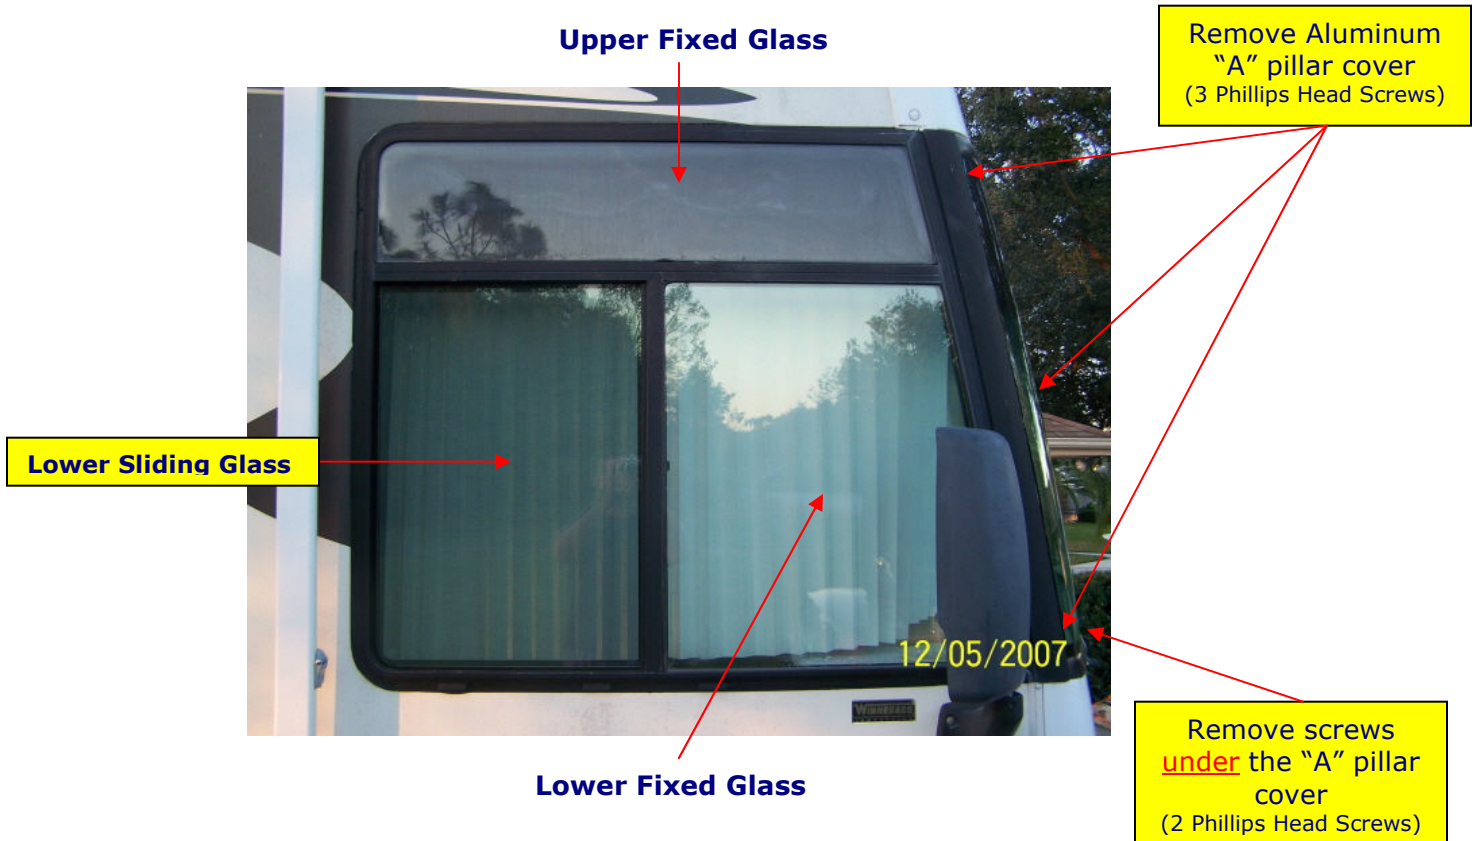
PASSENGER SIDE WINDOW

The passenger side window is a single window unit, comprised of three separate glass panels. Two panels (Upper and Front) are fixed pieces, and the third is the sliding window

In order to replace any of these glass panels, the entire window assembly must be removed from the body of the coach. This window is heavy, large and unwieldy.

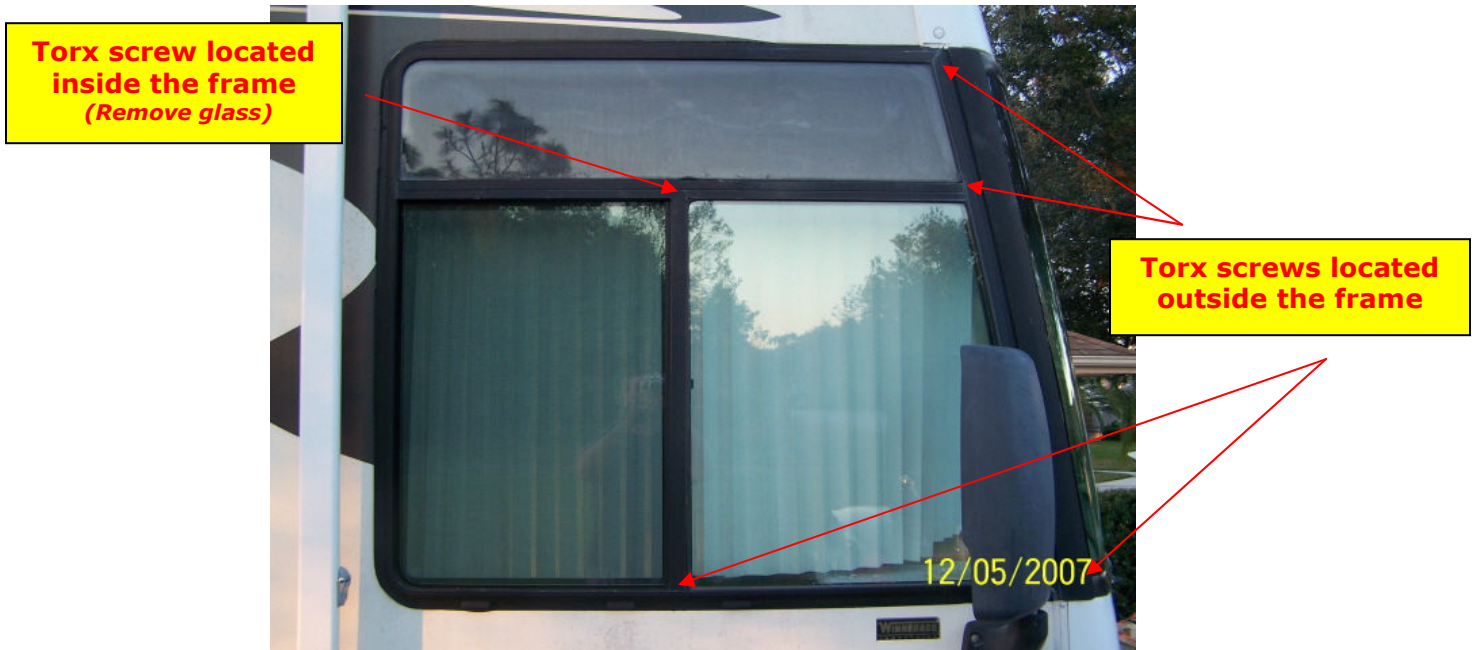
DISASSEMBLY

To disassemble the window, remove the Torx screws as indicated below. The window seals (glazing) used on this window are vinyl, and "U" shaped. If you poke, pull, or pry on the vinyl glazing, you will damage it and have to replace all of it. Otherwise, if you are careful, the glazing should be re-useable.

REMOVE TORX SCREWS

Once you remove the Torx screws, the window will easily come apart. Glass replacement is relatively simple, and should be fairly self-explanatory. If you have to replace the vinyl glazing, I found that a LIGHT touch with a heat gun will help mold the virgin vinyl transition the corners more easily. I noted that the glazing around the bottom of both fixed glass pieces had weep holes in the bottom, assumably to promote drainage. The new glazing I got from Atwood did not have any holes, so I used a handheld hole punch-to-punch holes in the bottom of the glazing.

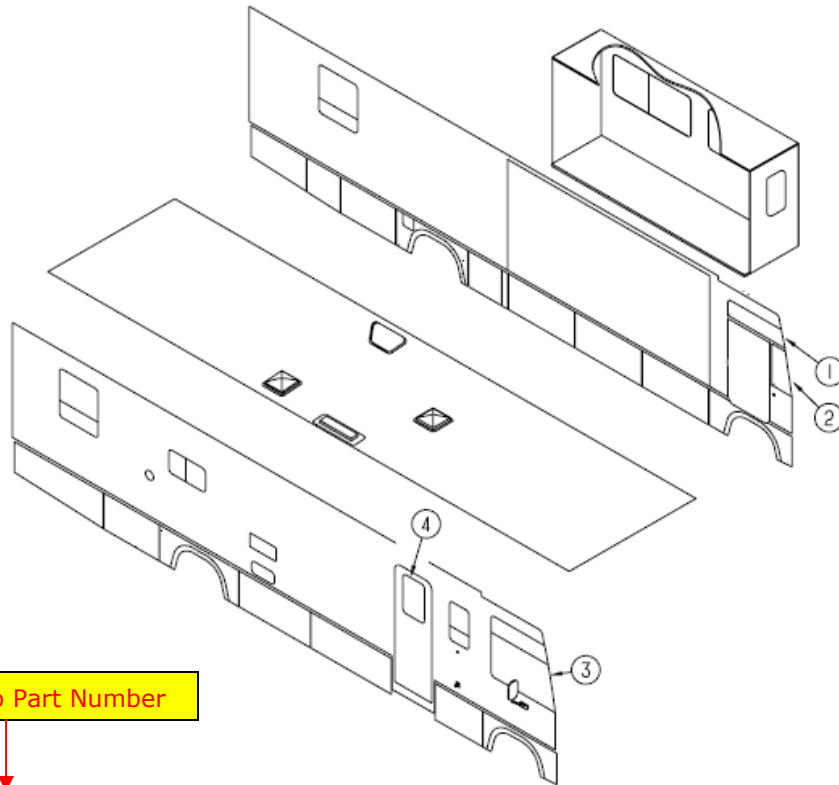
WINDOW & VENTS GROUP WINDOW & VENT LAYOUT

Winnebago Part Number

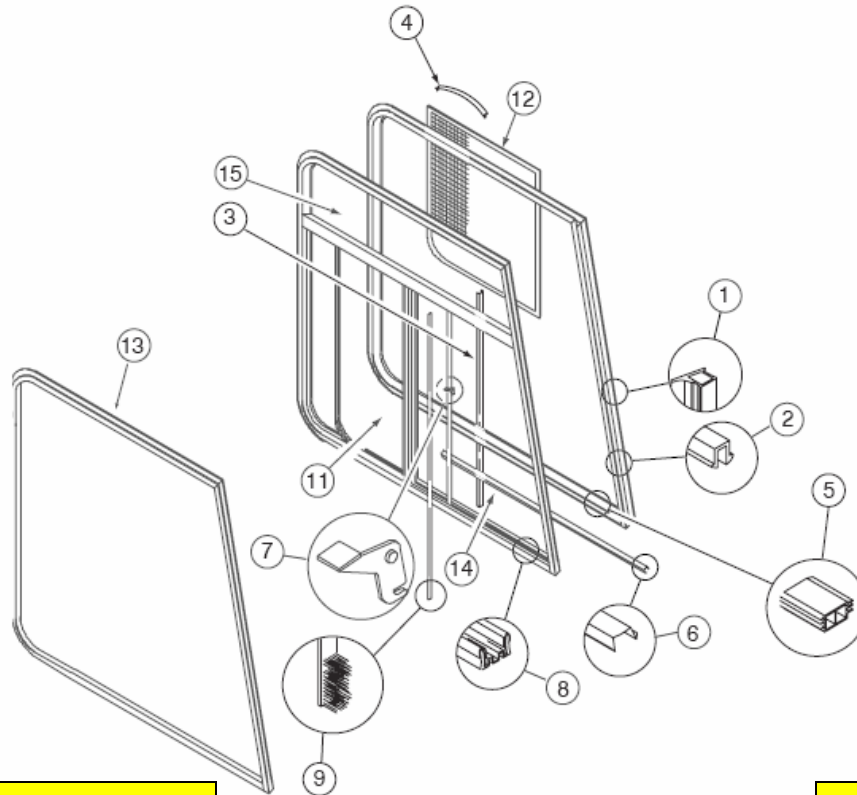
WINDOW & VENTS GROUP (CONTINUED) COMPONENT PARTS FOR WINDOW & VENT LAYOUT (CONTINUED)

Winnebago Part Number

Atwood Part Number
