Improved Info Center Backlighting

SS-2225
 Rev: n/a

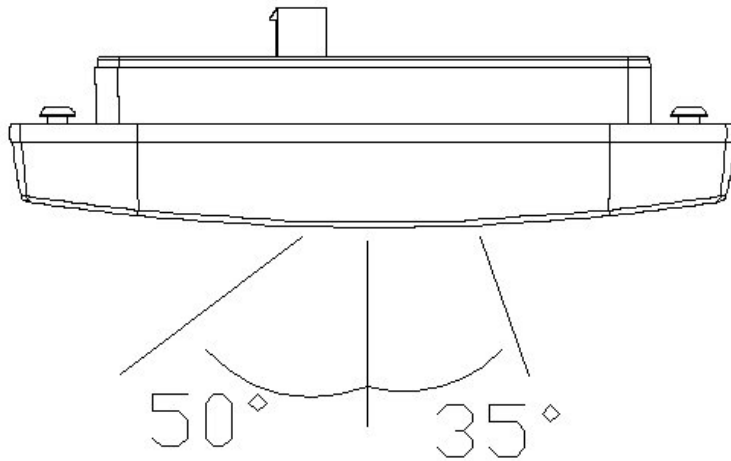
NEW BLACK AND WHITE
 STN INFO CENTER
 OPTREX

Freightliner Custom Chassis announces the availability of a new product improvement Info Center that uses a black/white Super Twisted Nematic module with film retardation (FSTN) for wider viewing angle and high black and white contrast. The original Info Center was a Graphic LCD Module display that used a green/black Twisted Nematic (TN) technology.

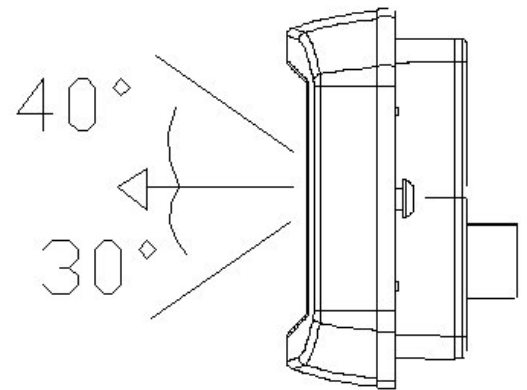
NEW Improved Viewing Angles

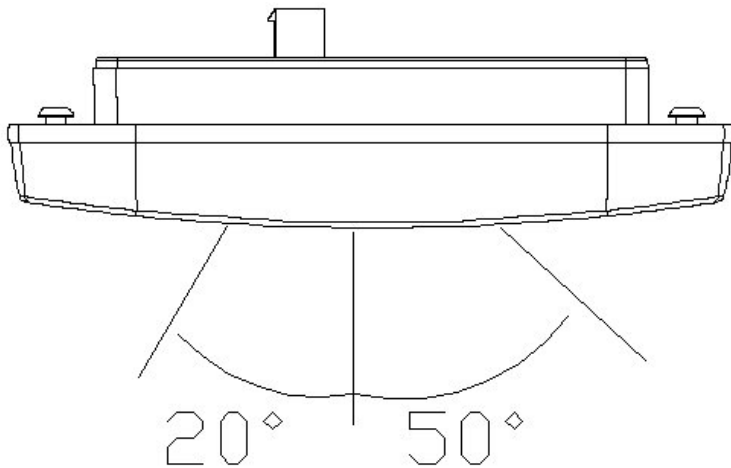
OLD GREEN AND BLACK
 TN INFO CENTER
 SEIKO

- 1. Make sure that recalls and campaigns such as FL425 have been done (**if applicable**). This will insure the latest available programming has been installed for your vehicle.*
- 2. Also make sure the display being replaced is an older green/black TN Display (KYS-15391018101).*
