## 2004 Itasca "Horizon" VDC (Vehicle Data Computer) Repair

COMPLAINT: The air pressure issue the rear air tank gauge only ready 80PSI when it should read 110PSI +.

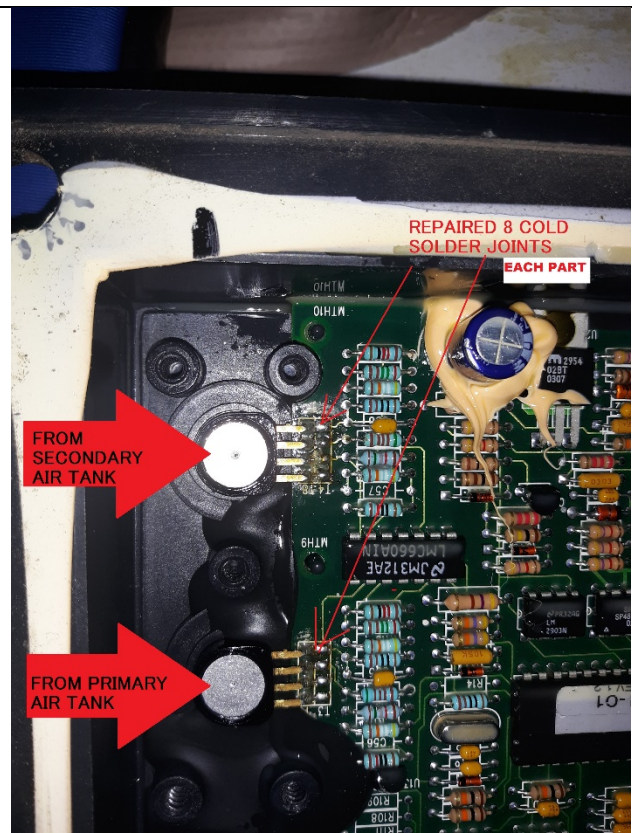
C) VDC Air Pressure Sensor Fix Due To "Cold Solder" Joints:

- \* Remove VDC off its 4 rubber mounts.
- \* Clean and split the VDC case by removing the back plate. It is glued down, but you can separate it using 2 thin putty knives.
- \* Remove the shiny metal cover piece and note the 2 nylon washers underneath. These go on top of each air sensor when you reassemble it and you must have these washers properly in place or air will leak out when you reassemble the VDC.
- \* I elected to take the VDC to an electronics TV repair shop so they can properly clean and re-solder 8 contact points on each sensor. So there are 16 total solder points, and they charged me \$50.

Note: There is corrosion coating that will take more time to remove than it will take to re-solder. ...Don't remove any solder. ...Just add a little more. ...And it's best to hang a wire clamp off each of the air pressure sensor leads so you don't over heat the sensor when soldering! ...When you are done soldering, coat solder points with "super glue" to protect it and to reduce vibration effects.

- \* Reassemble. Don't forget to put the 2 nylon washer back on top of the sensor!!!

\* No need to clean the old glue off the case... Just add new RTV Silicon to seal the case.... And I chose to use black tape over the seam for added dust control.

\* Torque to 15 lb-ft. so the rubber mounts can absorb the road vibrations. Don't over torque! And if you are like me and 99% of the other RV owners with bad "cold solder" joints in your VDC air pressure sensors, then your gauges should be reading normal! ...Or you may have a new normal, but your air tank gauge will read above 110PSI. (If your old reading was slightly higher... don't worry about it. It's a relative gauge pressure and does not have to be exact.
