## 2004 Itasca "Horizon" VDC (Vehicle Data Computer) Repair

COMPLAINT: The air pressure issue the rear air tank gauge only ready 80PSI when it should read 110PSI +.

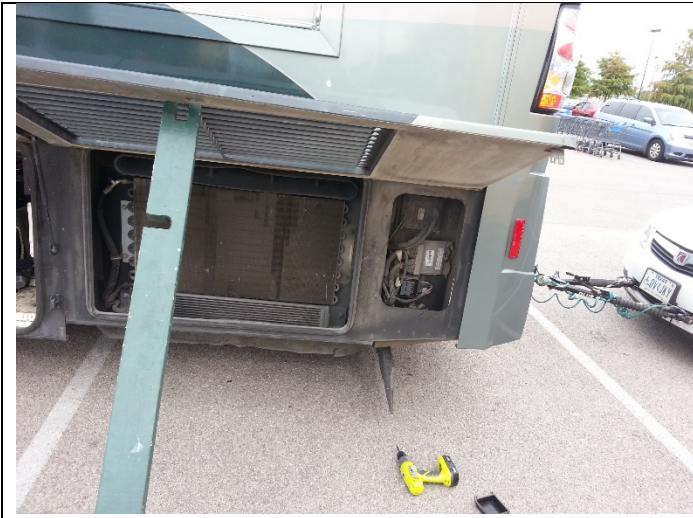
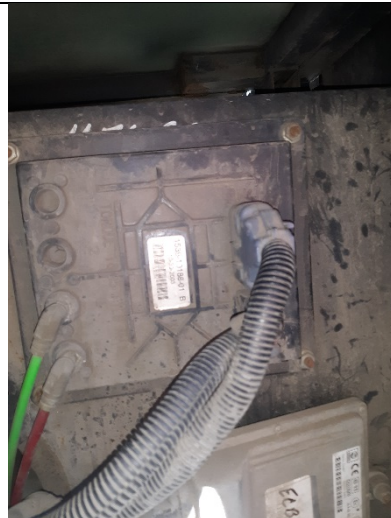
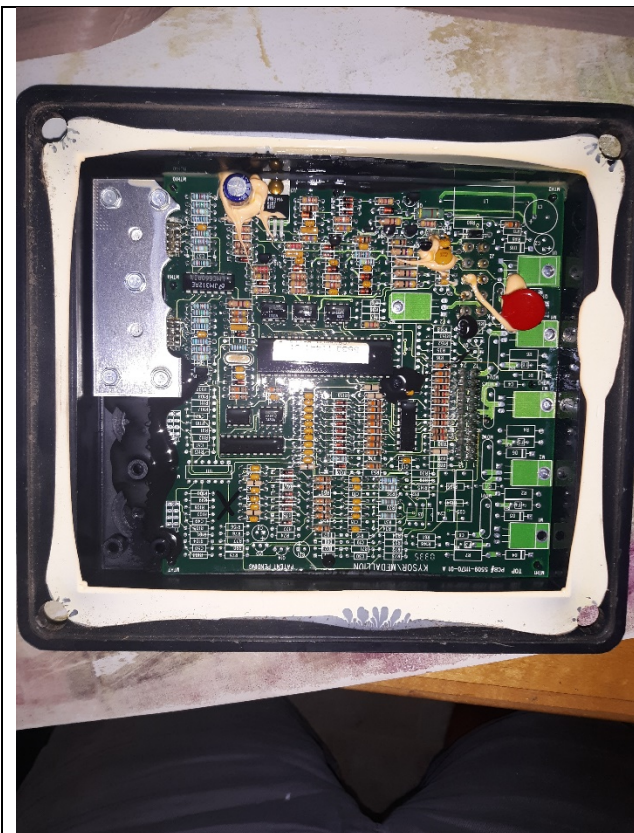
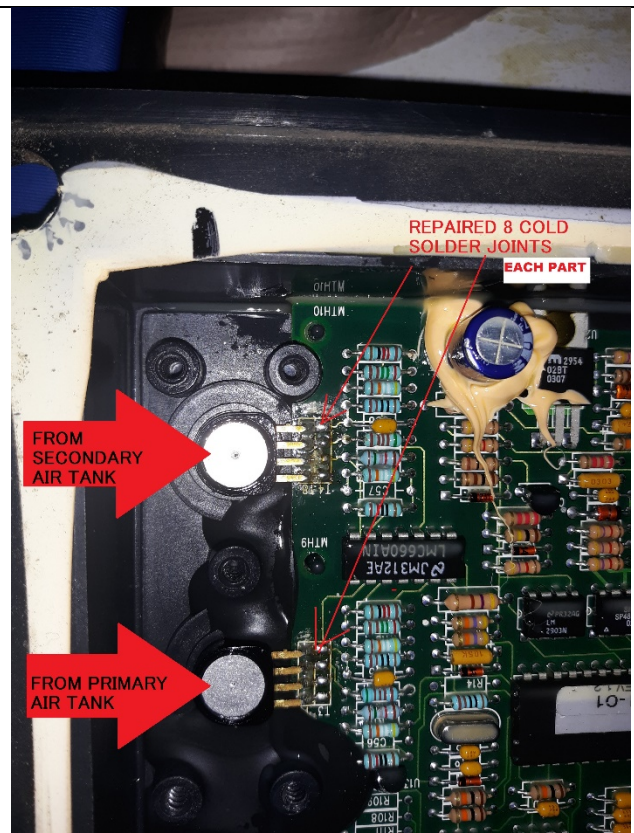
C) VDC Air Pressure Sensor Fix Due To "Cold Solder" Joints:

- \* Remove VDC off its 4 rubber mounts.
- \* Clean and split the VDC case by removing the back plate. It is glued down, but you can separate it using 2 thin putty knives.
- \* Remove the shiny metal cover piece and note the 2 nylon washers underneath. These go on top of each air sensor when you reassemble it and you must have these washers properly in place or air will leak out when you reassemble the VDC.
- \* I elected to take the VDC to an electronics TV repair shop so they can properly clean and re-solder 8 contact points on each sensor. So there are 16 total solder points, and they charged me \$50.

Note: There is corrosion coating that will take more time to remove than it will take to re-solder. ...Don't remove any solder. ...Just add a little more. ...And it's best to hang a wire clamp off each of the air pressure sensor leads so you don't over heat the sensor when soldering! ...When you are done soldering, coat solder points with "super glue" to protect it and to reduce vibration effects.

- \* Reassemble. Don't forget to put the 2 nylon washer back on top of the sensor!!!

\* No need to clean the old glue off the case... Just add new RTV Silicon to seal the case.... And I chose to use black tape over the seam for added dust control.

\* Torque to 15 lb-ft. so the rubber mounts can absorb the road vibrations. Don't over torque! And if you are like me and 99% of the other RV owners with bad "cold solder" joints in your VDC air pressure sensors, then your gauges should be reading normal! ...Or you may have a new normal, but your air tank gauge will read above 110PSI. (If your old reading was slightly higher... don't worry about it. It's a relative gauge pressure and does not have to be exact.

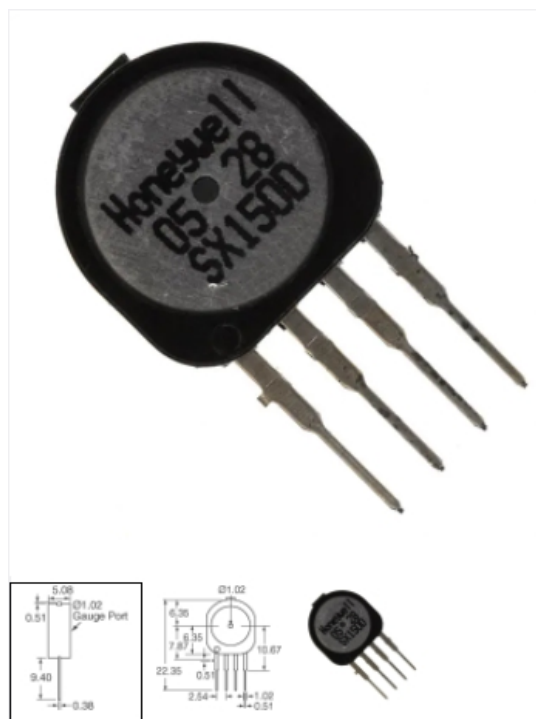
**Honeywell SX150D** (200PSI Max range) So you might want to use the sensor with part# **"NSCSSNN150PDUNV"** This is a 150PSI replacement part !!!!

The sx150d has been discontinued, but there are a few still available with some research. Next suitable replacement is **NSCSSNN150PDUNV**. This is a 150PSI replacement part !!!! ...and my 2004 Horizon uses 150PSI max air tank gauges.

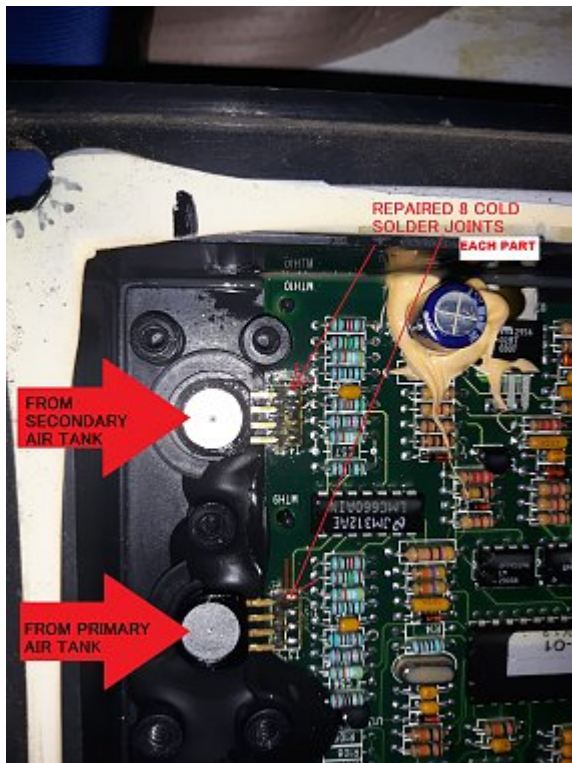
Note: The toughest part of the job was separating the red and green air lines to the VDC.

...And it the repair worked!!! ...Just make sure you put those 2 plastic washers on top of the air pressure switches, before you screw-down the metal cover plate!
