2004 WINNEBAGO HORIZON DIESEL PUSHER - DASH A/C 134a NOTES

(Diagnose Clogged Receiver-Dryer, 2 Pressure Switches / Expansion Valve / Compressor)

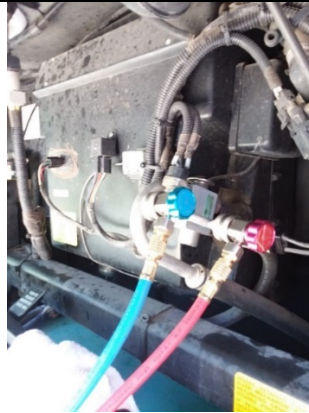
From Left to Right, notice the AC wire connector, the A/C relay, Thermostat, Blue LP Schrader port, Red HP Schrader Port... surrounded by a Binary Switch on the left and a Condenser Fan Control Switch on the right. And in the background that shiny block is your TXV-Expansion Valve. (You should clean all these electrical contacts!)

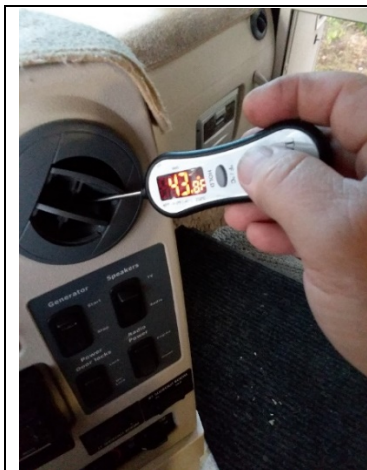
SUCCESS: Here's the finished results with an outside air temperature showing 88F... and our digital meat thermometer gauge read 43F... in the dash vent! That's a -45F difference! Finally!!!

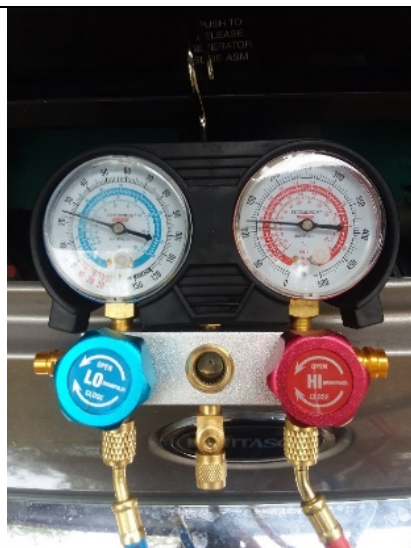
BEFORE DRYER FIX:

Our compressor clutch kept turning on-off-on; and Dryer inlet tube was warm, but outlet side was very cold... and the gauges read 20-22PSI on the Low Side as the compressor quick cycled; and the High-Side would not get over 125 PSI.

AFTER DRYER FIX:

We got a -45F difference from Outside air temp vs Dash Temp. And our gauges are now 24PSI on the Low-Side and steady; and 120PSI on the High-Side, with the outside air temperature at 80F. (We expected at least 150-200 PSI on the High-Side but didn’t get it.) And the A/C is blowing -45 degrees colder than the outside air temp.

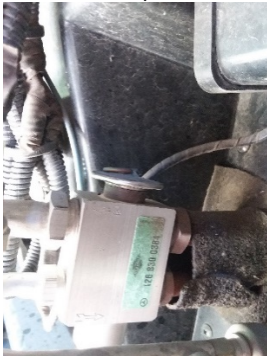
Mercedes Expansion Valve Part#: 126-830-0384

Notice the copper capillary tube on top. And when the 134a liquid in the tube boils I think it tells the TXV-Expansion Valve to let more or less 134a through to the evaporator. (Like a squirt bottle.)

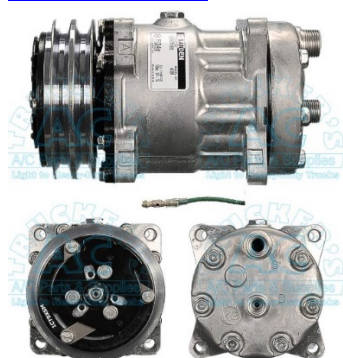
SANDEN #4709 (FORD TYPE – USES PAG100 OIL. “NEW HOLLAND” STYLE???)

YOUR COMPRESSOR: On my 2004 Itasca Horizon 40AD (Cummins -450HP) our rig came with a SANDEN \$4709 (Ford Type Compressor) that uses PAG100 oil.

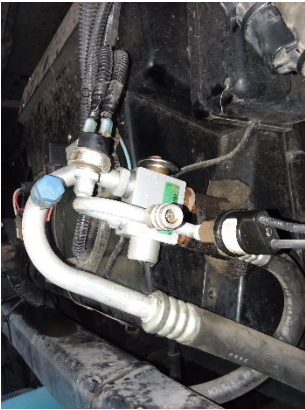
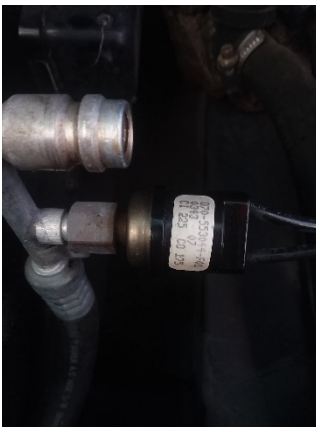
CONDENSER FAN SWITCH ON OUR 2004 ITASCA HORIZON

*Freightliner HP (Pigtail) Switch installed in
2004 Itasca Horizon Part # : 70-553044-F01
Cut-Off = 225PSI CUT-IN=175PSI ????*

We are not sure of the specs for this Condenser Switch.
So we recommend you order it through Winnebago.
