2004 WINNEBAGO HORIZON DIESEL PUSHER - DASH A/C 134a NOTES

(Diagnose Clogged Receiver-Dryer, 2 Pressure Switches / Expansion Valve / Compressor)

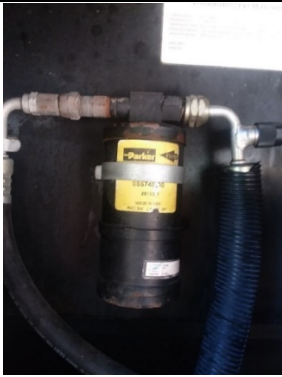
OEM PARKER Receiver-Dryer (Vintage 2003) with HP-Red Schrader port on right. This line comes from your Condenser. **Napa Cross: #218093 (\$34)**; Freightliner Part # GAFP110704 (\$75). Other crosses include A/C/Delco #17-9969 or Fleetwood# 151779 or RV218396.

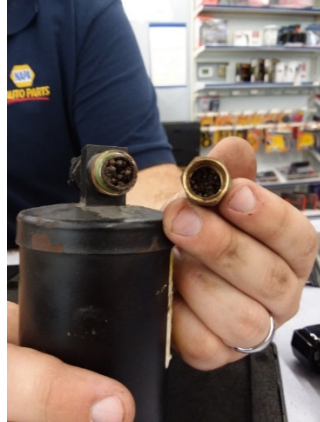
Note the check-valves are used to block descant from contaminating the A/C System in the event the Receiver Dryer fails.

THERE ARE 2 INTERNAL CHECK VALVES ON THE OUTPUT SIDE OF THE RECEIVER-DRYER: Our A/C Delco Receiver-Dryer has two “back-to-back” check valves screwed into the Dryer’s “Line-out”. (The Line-out is on the smaller side of the Dryer. These check valves do NOT come with the Dryer and are hard to get. The Dryer is supplied Freightliner, but apparently Winnebago supplied the check valves. (Note: You need 2 check valves facing back-to-back inside.)

Since we did not want to wait for a new check valve to arrive in 3-5 days, we took the risk and cleaned our valves with spray silicon so as to not damage the little O-rings on the check valve. And we used solvent on a rag to clean the rusted spring. This approach worked fine for us.

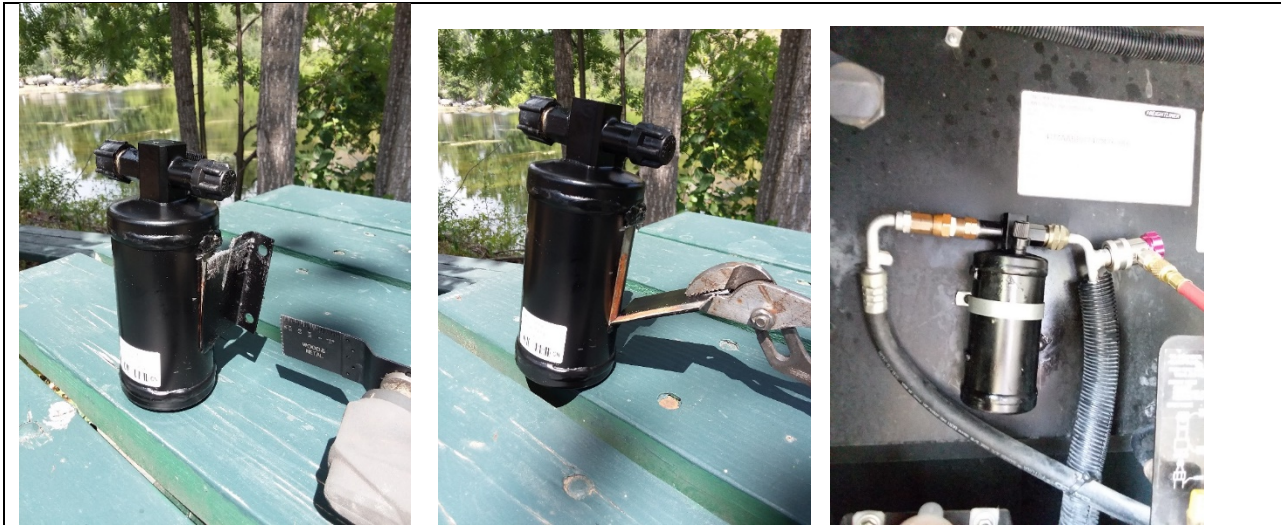
Note: FLOW ON OUR DRYER IS FROM RIGHT TO LEFT !!!! And you can tell which-is-which, because the input side of the Dryer is larger than the output side. This will be more obvious when you look at your Dryer.

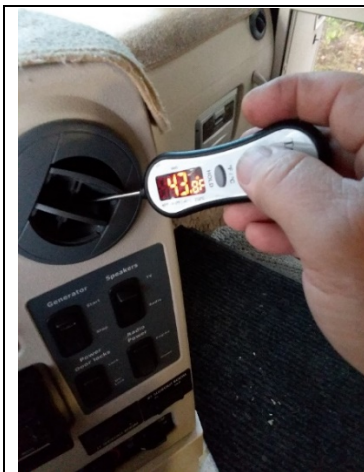
SUCCESS: Here's the finished results with an outside air temperature showing 88F... and our digital meat thermometer gauge read 43F... in the dash vent! That's a -45F difference! Finally!!!

We got a -45F difference from Outside air temp vs Dash Temp. And our gauges are now 24PSI on the Low-Side and steady; and 120PSI on the High-Side, with the outside air temperature at 80F. (We expected at least 150-200 PSI on the High-Side but didn’t get it.) And the A/C is blowing -45 degrees colder than the outside air temp.

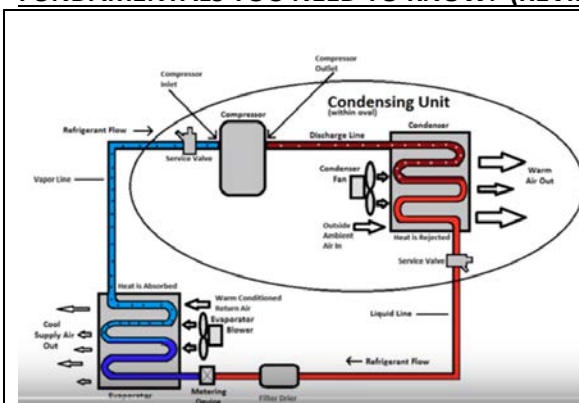
FUNDAMENTALS YOU NEED TO KNOW: (REVIEW CHART BELOW AND THINK ABOUT THE FOLLOWING)

* We want to measure (PSI) at the hottest or highest Pressure point. And on our 2004 Itasca Horizon we have 2 different HP-Red-Schrader Valves we can use in front of our firewall ... and above the generator up front. Everything is in plain view and easy to inspect.

One High Pressure (HP) port is just before the Dryer, and the other HP port is just before the TXV-Expansion Valve, but if you trace the A/C line you will see it is also the port leading out of your Dryer. This can help you test for a clogged Dryer or a bad expansion valve.

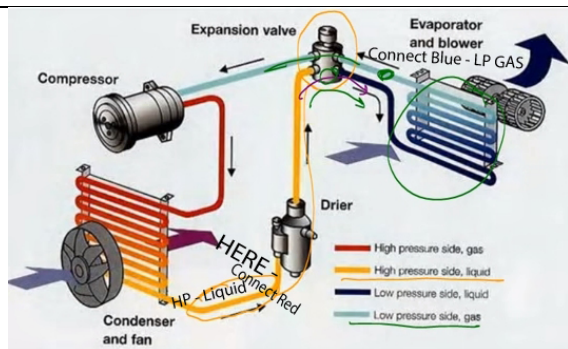
These charts are very similar, but you need to study both of them to understand where and at what and where pressure/temperature changes occur.

This is where the refrigerant undergoes a “State Change” from liquid to gas and back to liquid again. And each time it does you are either giving off heat energy or absorbing heat energy.

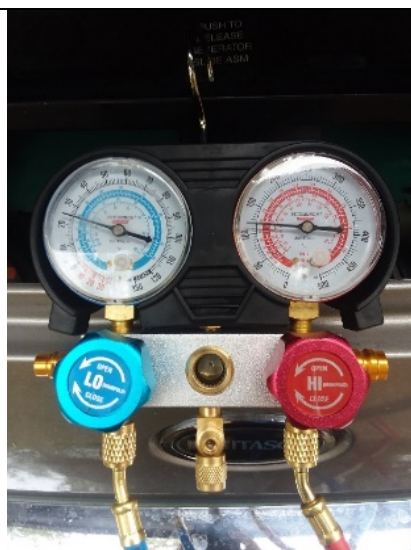
BEFORE DRYER FIX:

Our compressor clutch kept turning on-off-on; and Dryer inlet tube was warm, but outlet side was very cold... and the gauges read 20-22PSI on the Low Side as the compressor quick cycled; and the High-Side would not get over 125 PSI.

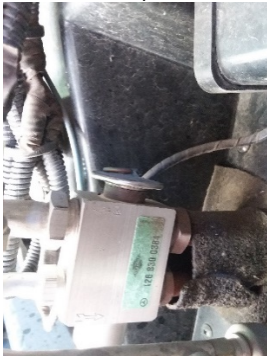
Mercedes Expansion Valve Part#: 126-830-0384

Notice the copper capillary tube on top. And when the 134a liquid in the tube boils I think it tells the TXV-Expansion Valve to let more or less 134a through to the evaporator. (Like a squirt bottle.)

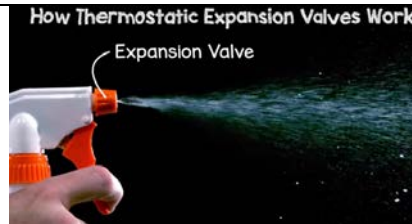
The A/C expansion valve regulates the flow of Freon. Plus it supports the process of Freon changing from a HP-liquid to a HP-gas.

As the Freon expands, it becomes cooler, and with the help of your evaporator and dash fan, heat from your cabin air is absorbed by the "Change In State" and you perceive that as cold A/C air out your vents.

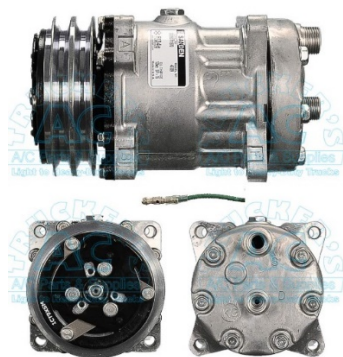
SANDEN #4709 (FORD TYPE – USES PAG100 OIL. “NEW HOLLAND” STYLE???)

YOUR COMPRESSOR: On my 2004 Itasca Horizon 40AD (Cummins -450HP) our rig came with a SANDEN \$4709 (Ford Type Compressor) that uses PAG100 oil.

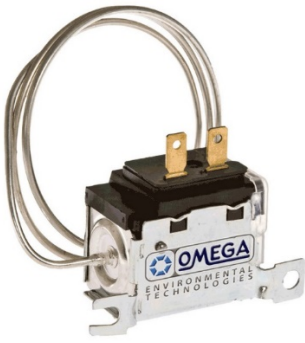
PICTURE OF YOUR EVAPORATOR THERMOSTAT SWITCH (\$30)

This switch has a 24" copper probe used to measuring the temperature of your Evaporator Box. It is an interrupt switch in series with your HP-Binary Switch that protects your Evaporator from freezing.

The Thermostat is Cold Off: 31F and Cold On: 39F

*This is a "normally closed" switch, so if you think the switches bad then just jumper up with a fuse. Then see if your AC System works or not?

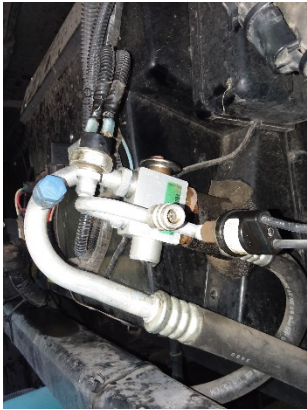
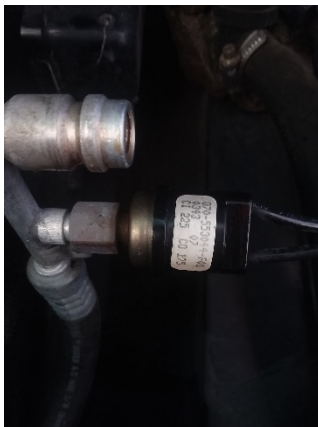
CONDENSER FAN SWITCH ON OUR 2004 ITASCA HORIZON

*Freightliner HP (Pigtail) Switch installed in
2004 Itasca Horizon Part # : 70-553044-F01
Cut-Off = 225PSI CUT-IN=175PSI ????*

We are not sure of the specs for this Condenser Switch.
So we recommend you order it through Winnebago.

Winnebago Part # 10393001716 for \$49.

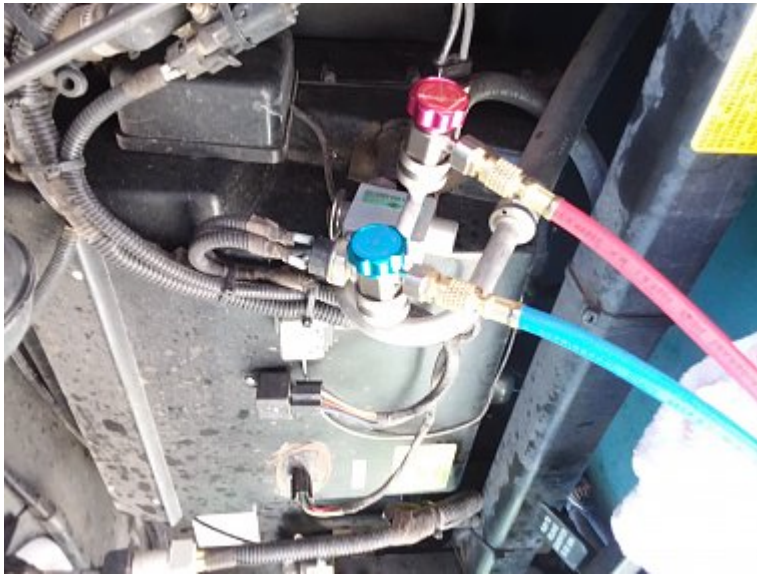
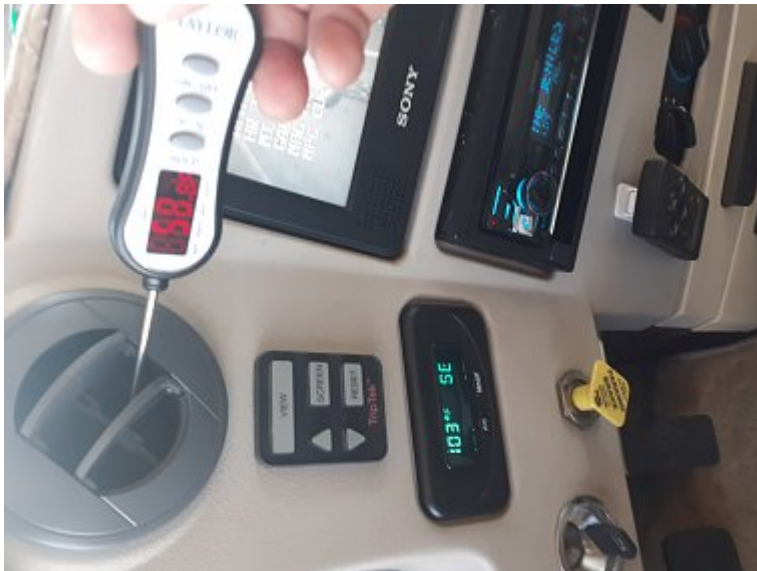
R/C DIAGNOSIS CHART

Low Side	High Side	Duct Temp	Possible Cause
Low	Low	Warm	Low refrigerant charge
High	High	Warm	Overcharge of refrigerant
High	High	Some Cool	Air in the system or Overcharge
Normal	Normal	Warm	Moisture in the system
Low	Low	Warm	Expansion valve stuck closed
Low	Low	Warm	Orifice tube plugged
Low	Low	Warm	High side restriction
High	Low	Warm	Compressor or control valve failed
