Windshield Wiper Over Travel

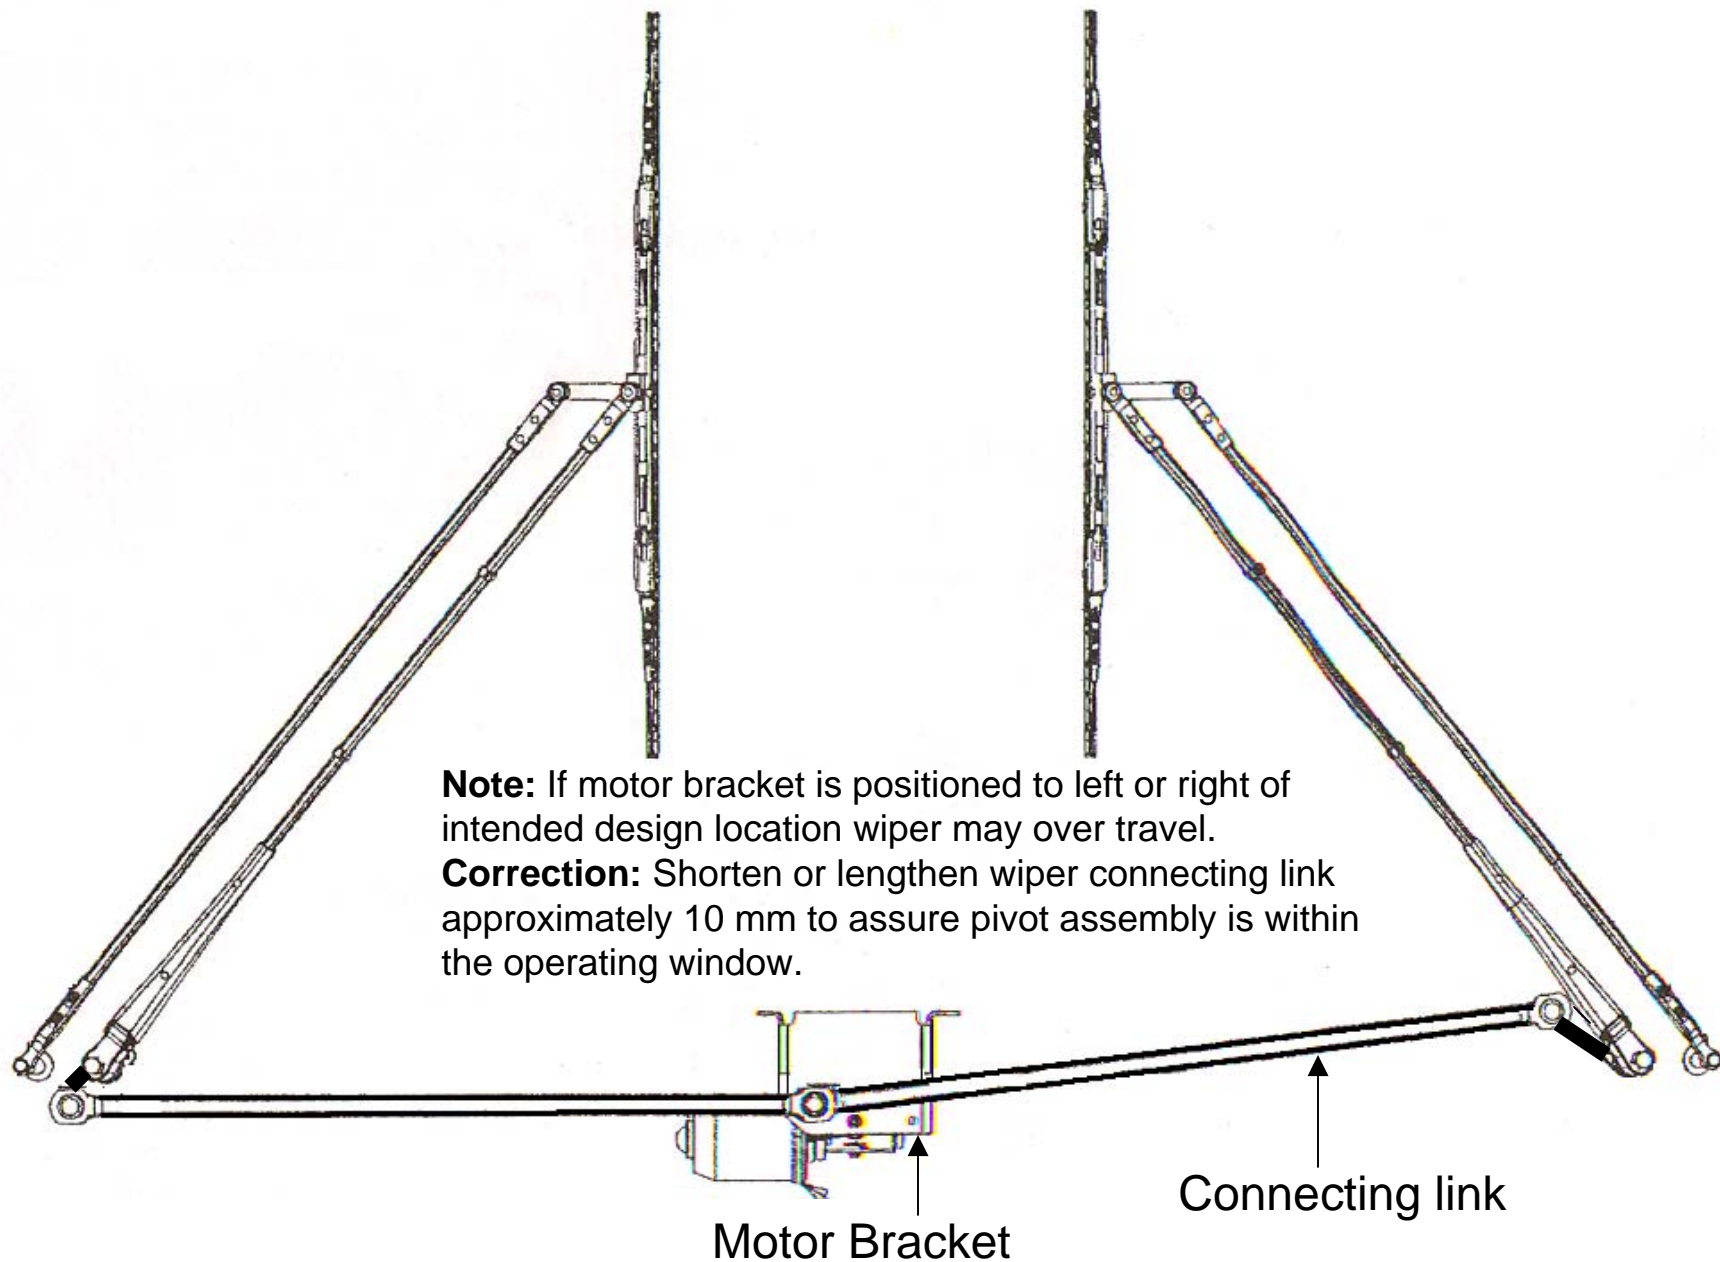
Wiper configuration used with two windshields.

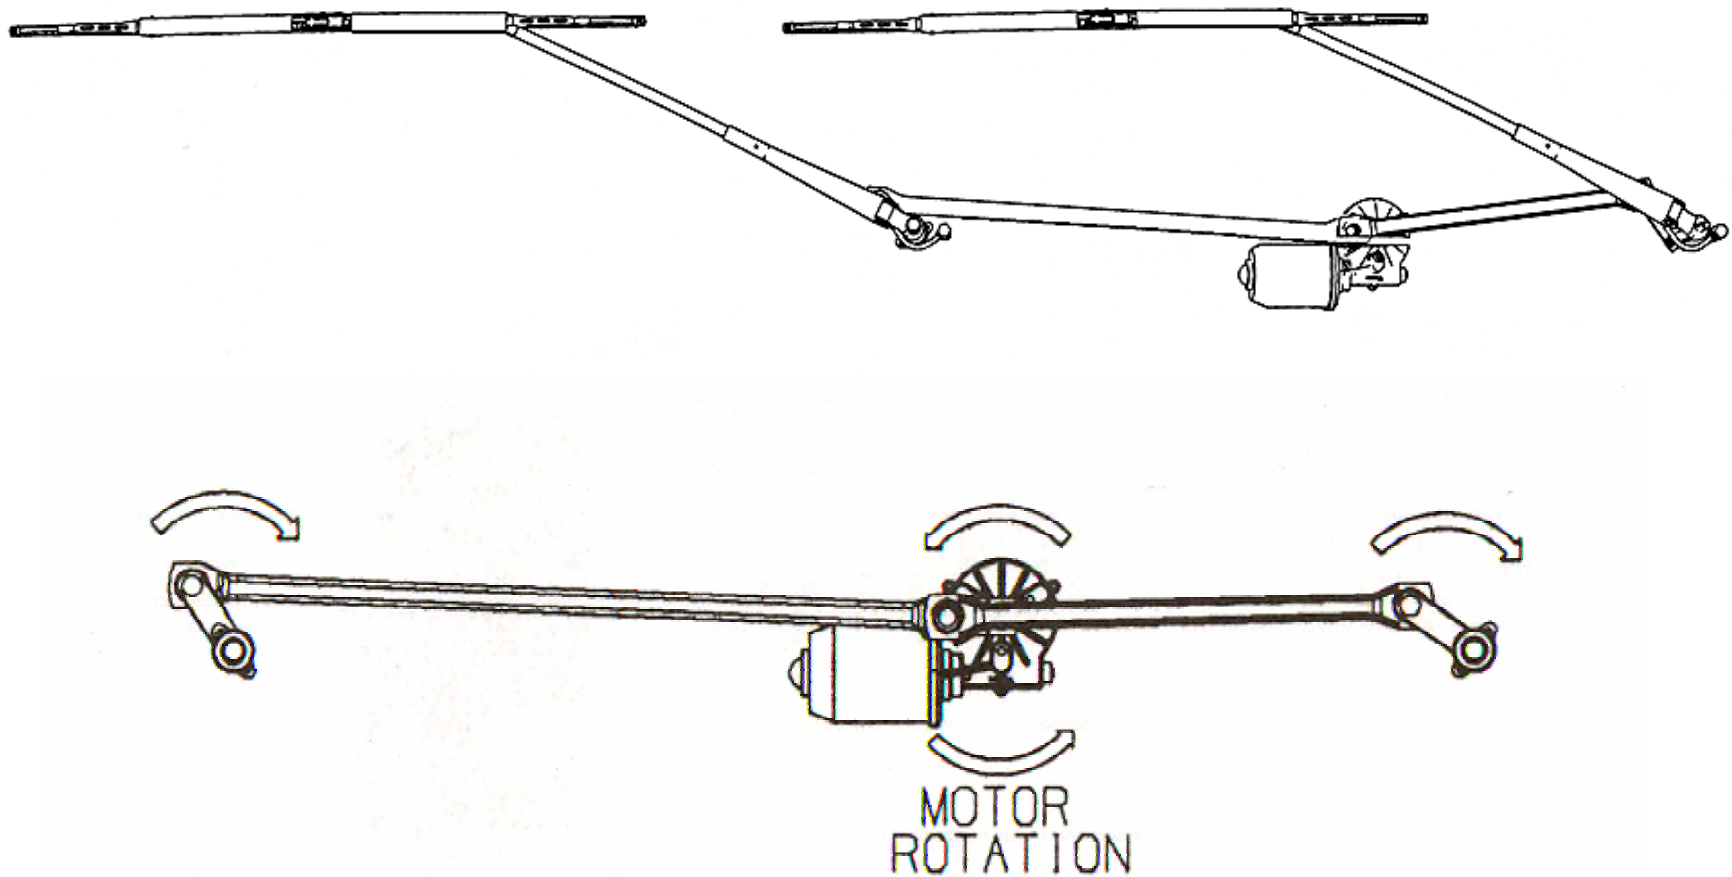
Wiper configuration used with one piece windshield.

If wiper motor bracket is mounted to far right or left of design intent position the pivot arm will be out of the operating window which may cause wiper to over center.

Correction: Shorten or lengthen wiper connecting link approximately 10 mm to assure pivot assembly is within the operating window.
